**CHANGES IN RIVERINE HYDROLOGY ON ST. THOMAS,  
U.S. VIRGIN ISLANDS: A PILOT STUDY**

Lloyd Gardner, M.Sc.  
WRI Research Associate

March 3, 2008

Virgin Islands Water Resources Research Institute  
University of the Virgin Islands

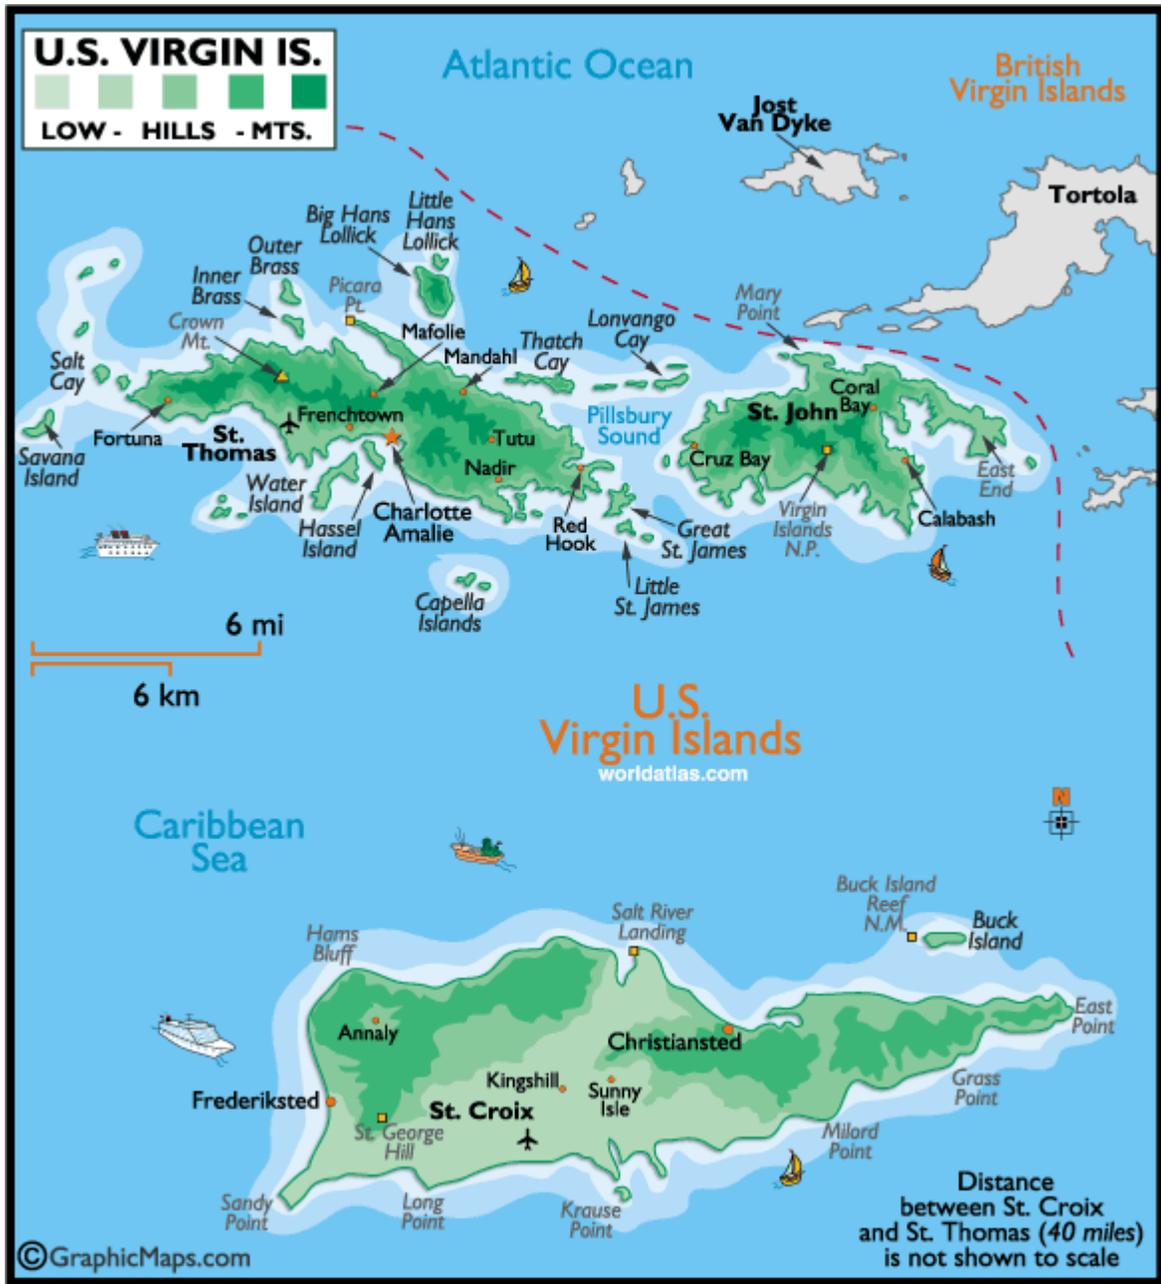
Figure 1: Map of the U.S. Virgin Islands

St. Thomas, with a size of approximately 31 sq. miles (81 km<sup>2</sup>), is the second largest island in the group of islands forming the United States Virgin Islands (Figure 1). The island is 13 miles long by 4 miles wide, and is aligned on an east to west axis. The topography of the island is fairly hilly, consisting of a main ridge running east to west along the center of the island, smaller branching ridges, and a small percentage of flat land. The island is volcanic in nature, with a shallow cover of mixed clay soils. The highest point is Crown Mountain, which reaches an elevation of 1,556 ft. (475 m).

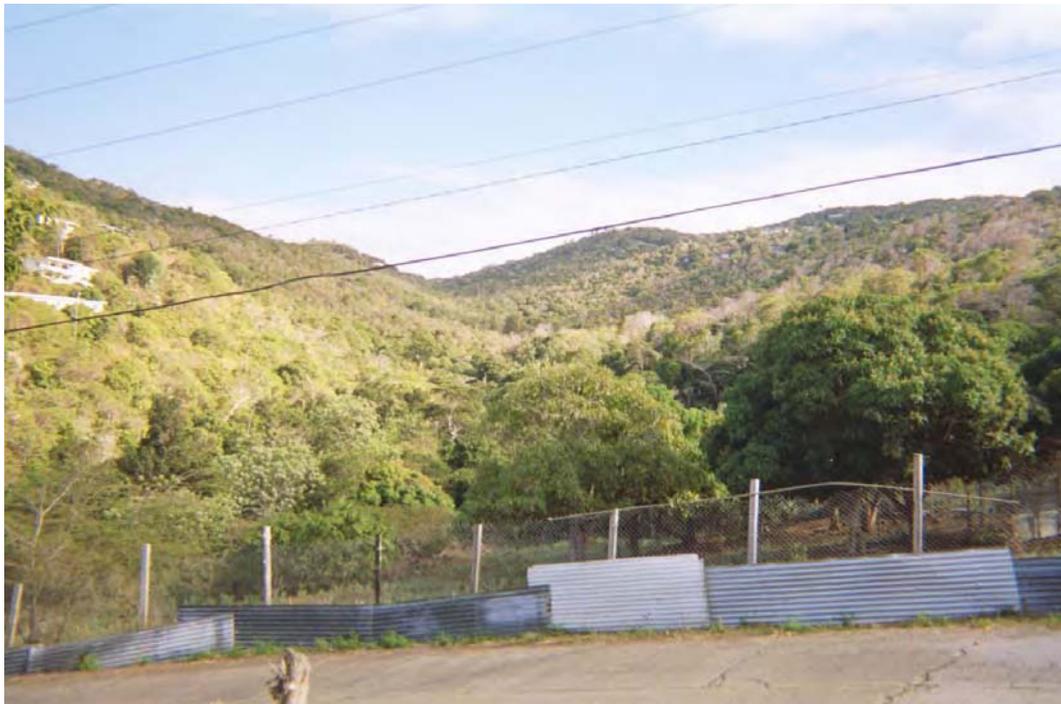
The main channel of the Bonne Resolution Gut starts high up in the watershed, close to the main ridge that runs along the east-west axis of St. Thomas, and drains to the northern coastline of the island. The drainage area for the gut is approximately 0.4 square miles (<http://nwis.waterdata.usgs.gov/vi/nwis>). The area of the watershed that drains to the gut is moderately disturbed by human activity, primarily agriculture and residential development. The vegetation in the upper reaches of the drainage basin is Gallery Forest, and the cover is mostly intact (Photo 1). The vegetation along the edges of the gut varies in density, structure, and diversity as the gut descends to the shoreline (Photos 2-4).

Photo 1: Sub-Watershed contributing to the Bonne Resolution Gut

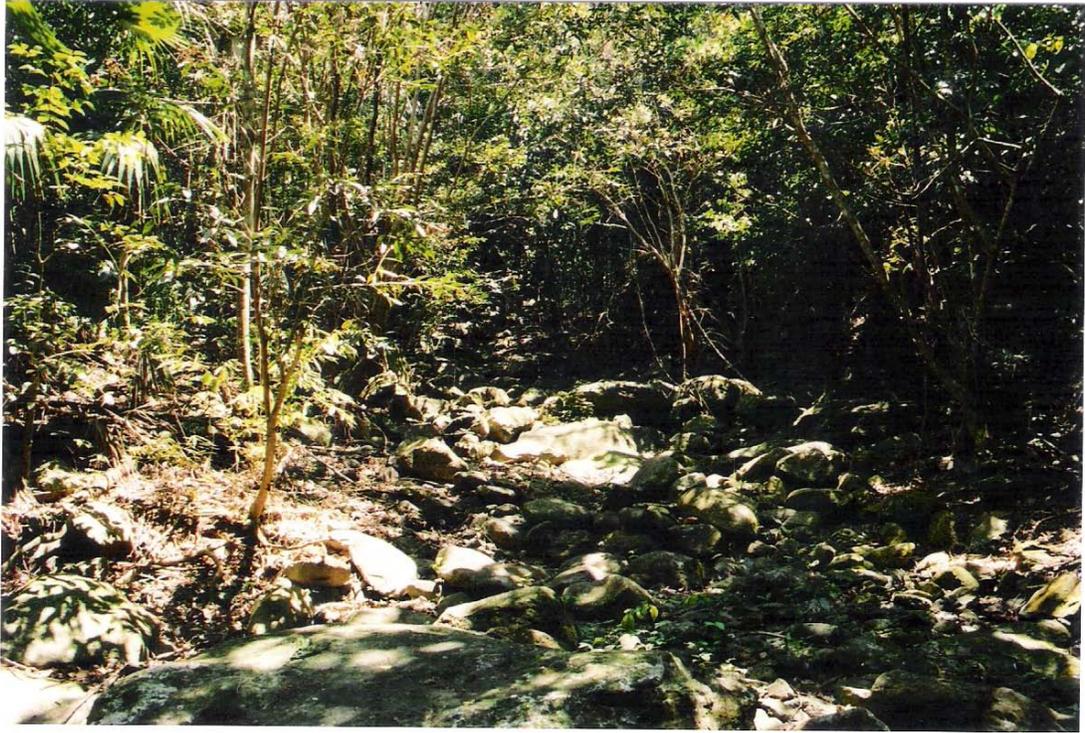
The upper portion of the gut is characterized by a shallow channel, gentle-sloping sides, and a mixture of vines and shrubs growing within the channel (Photo 2). Pools of standing water are absent from this portion of the gut. The bottom of the channel is mainly rock, but a thin layer of soil is present.

Photo 2: Upper Portion of the Bonne Resolution Gut

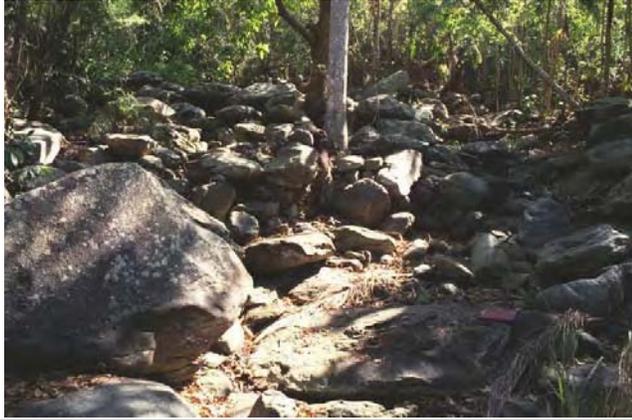
From approximately 200 meters above (south of) the bridge to an area just south of the Dorothea Condominiums (on the coast), the gut gets increasingly steep, and is filled with large boulders (Photo 3). Trees (within the gut) are few in number along this stretch, but standing pools of water are numerous. The larger pools of water also support water reeds (Photo 4), indicating that some of the pools may be permanent. The largest pool of water in this gut was located at the mouth of the gut, where a sand bar formed a natural barrier (Photo 5). Some of the natural and man-made features along this strip of the gut were mapped using GPS (Figure 2 and Appendix 2).

Photo 3: Mid-channel of the Bonne Resolution Gut

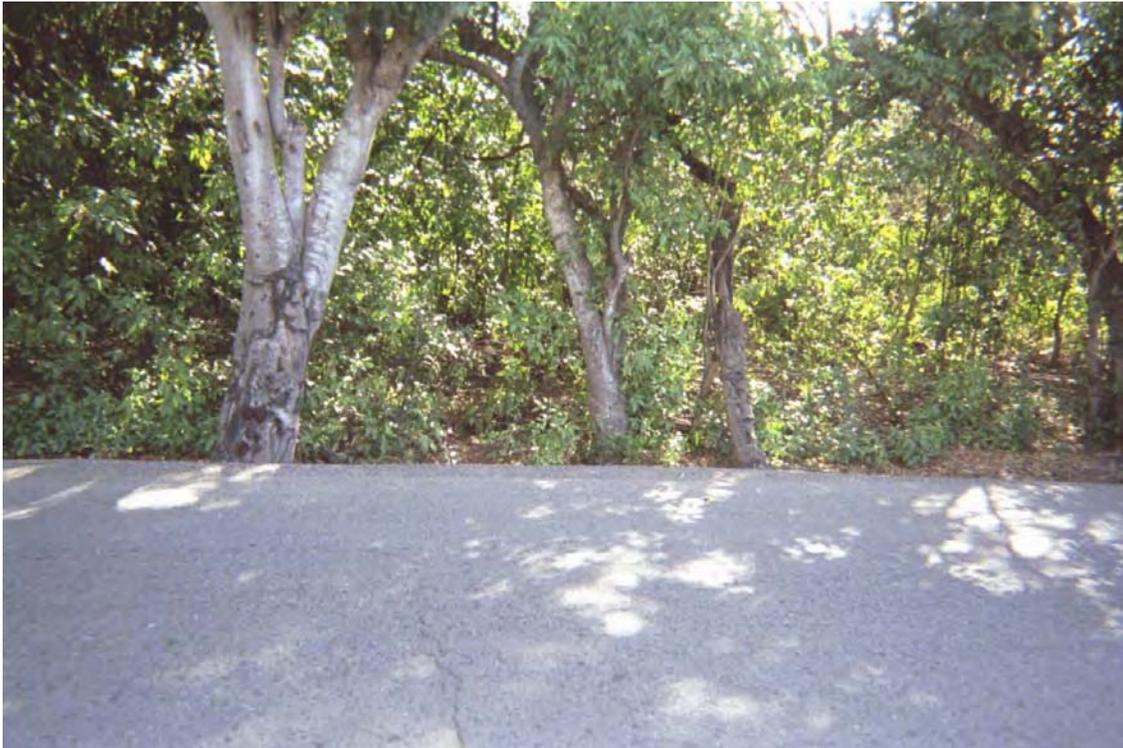
Photo 6: Western (Upslope) Side of Culvert along Smith Bay Main Road

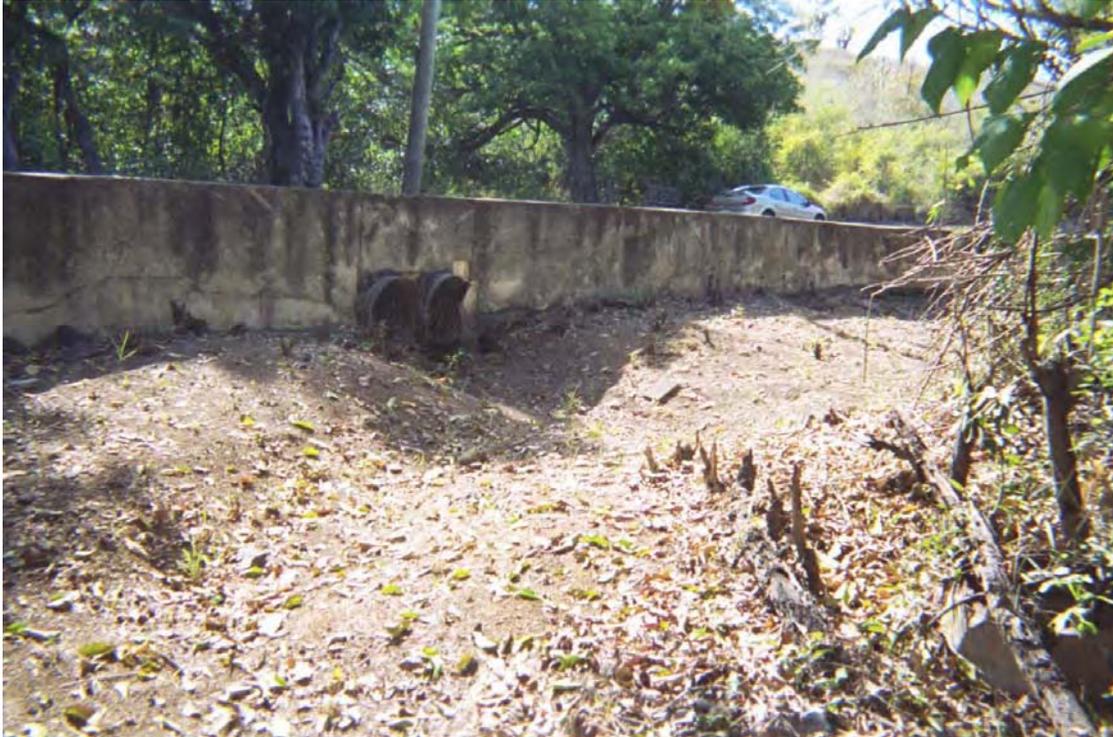
Photo 7: Eastern (Downslope) Side of Culvert along Smith Bay Main Road

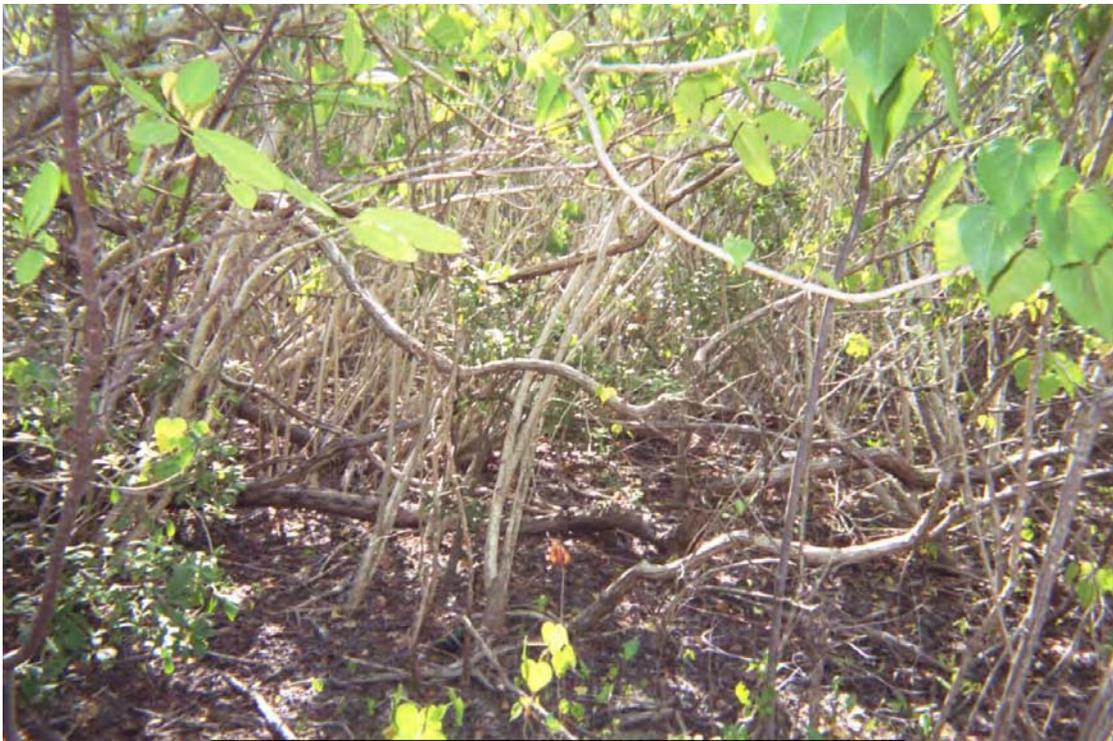
Photo 8: Vegetation between Road and Seashore

The distance between the main road and the seashore is approximately 150 metres, and is mostly at sea level. The vegetation along the main road is composed of a narrow fringe of mixed vegetation (mostly *Acacia* sp. and Guinep), but the stand is dominated by White Mangrove (*Laguncularia racemosa*) and Seaside Mahoe (*Thespesia* sp.) (Photo 8). The raised sand berm along the coastline also supports mixed vegetation, dominated by *Acacia* sp. (Photo 9).

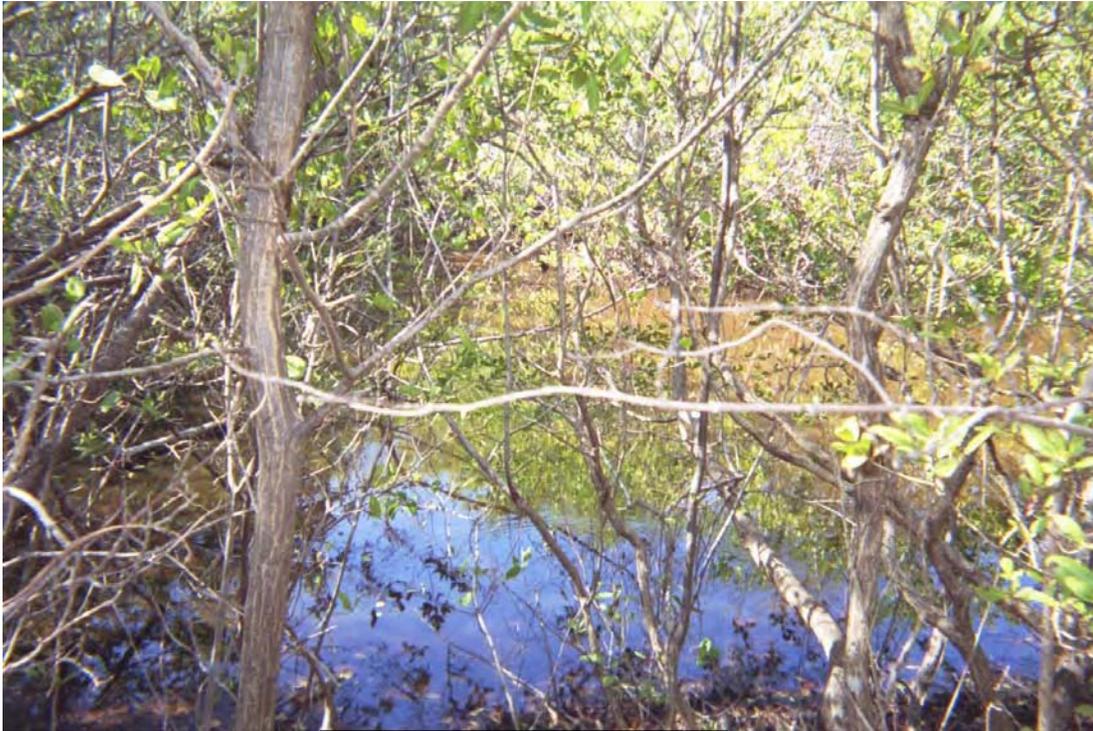
The moist nature of the sand, the presence of a dense network of crab holes, and the existence of breathing roots of the mangroves indicate that the site is inundated for long periods. There is a permanent pool at the end of the drainage channel (Photo 10 and Figure 3).

Photo 10: Smith Bay Pond

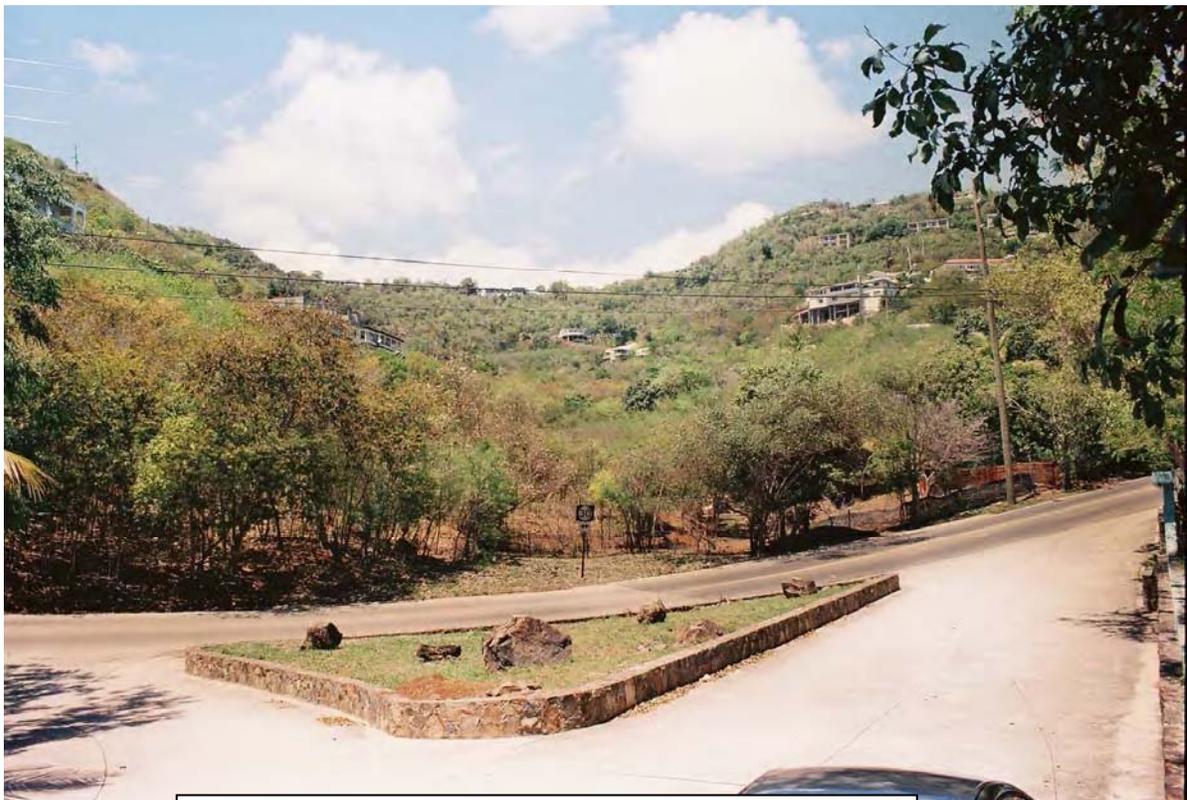
Photo 11: Frenchmans' Bay Gut, above Main Road

The sub-watershed that drains to the Frenchman's Bay Gut is fairly small, and though the upper slopes are fairly steep, the discharge volume of the surface runoff is apparently insufficient to create a deep channel. In fact, the drainage channel up-slope (north) of the main road (Route 30) is almost undefined (Photo 11). Below the main road, the drainage channel is narrow and shallow (Photo 12). Approximately midway between the main road and the beach, the gut crosses the private (dirt) road on the Frenchman's Bay Development property. Below this private road, the gut smooths out and essentially disappears as a flat area behind the beach (Photos 13 and 14)

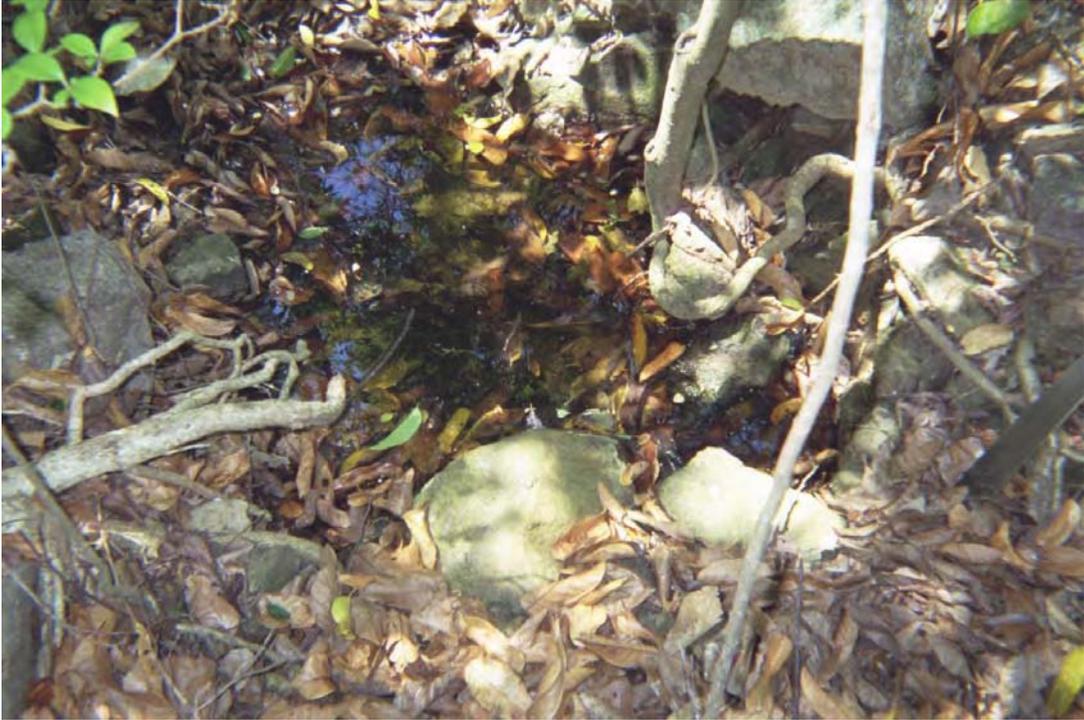
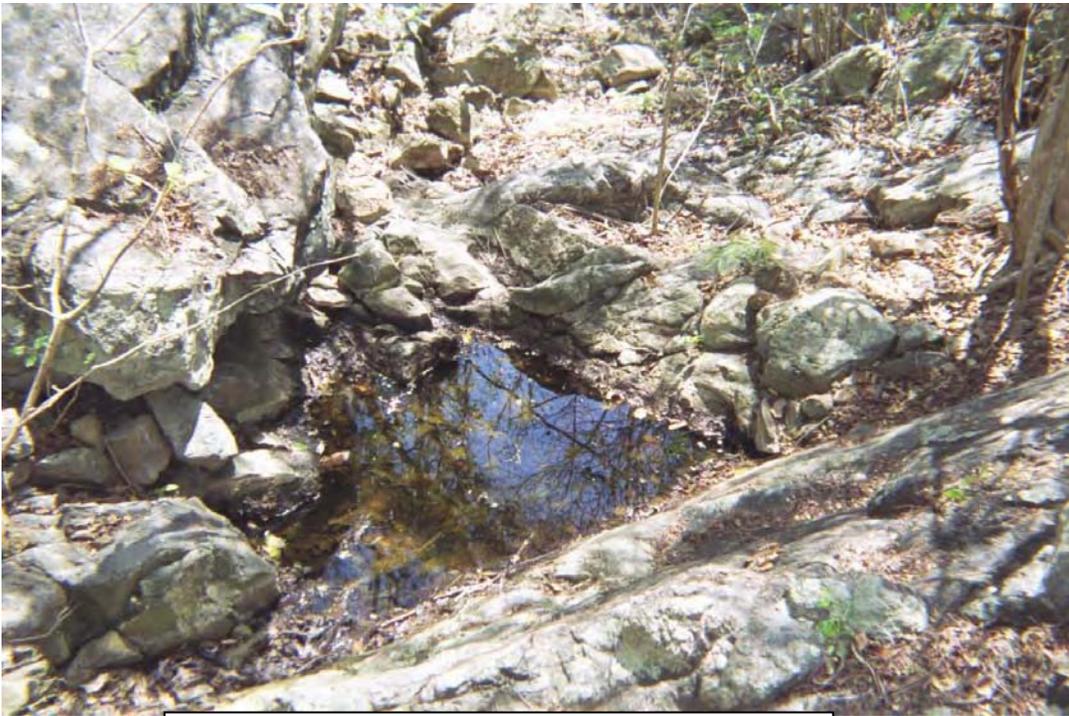
No running water was observed in the Frenchman's Bay Gut, though a small number of very small pools were observed during two visits to the site. These pools, contained in rock, appeared to be simply leftover from surface runoff resulting from a rainfall event (Photos 15 and 16).

Photo 15: Pool in Frenchmans' Bay Gut

Photo 16: Largest Pool in Frenchmans' Bay Gut

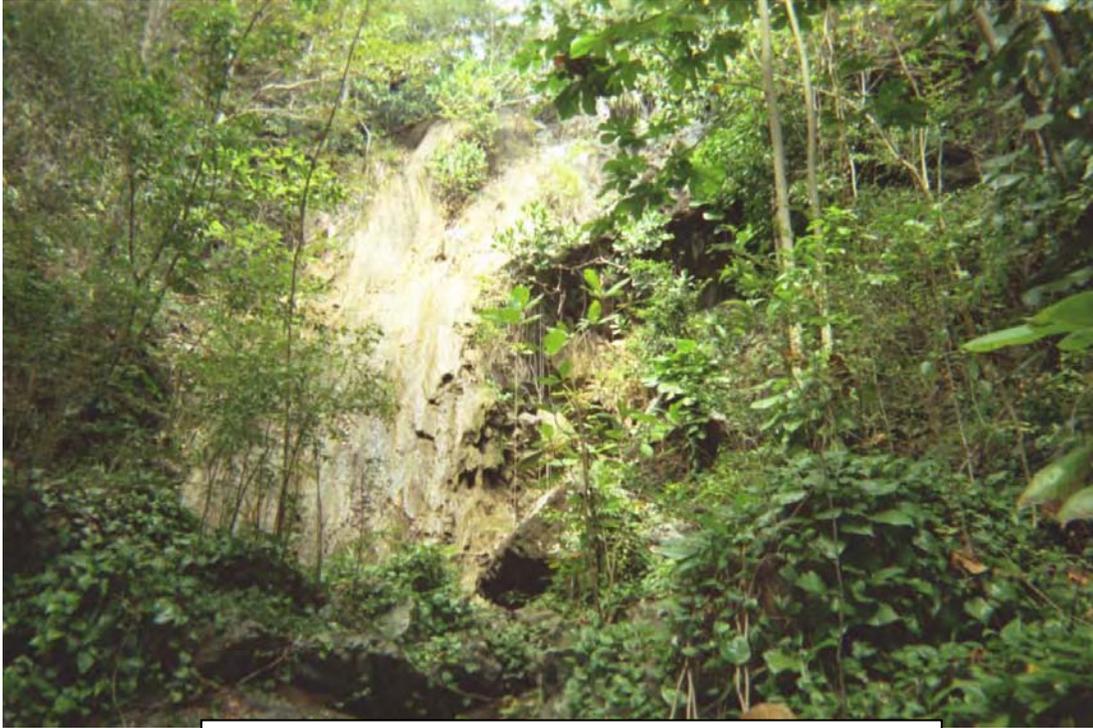
Photo 18: Waterfall in Middle Portion of Contant Gut

In spite of the steepness of the surrounding slopes, the gut itself is fairly shallow, and the only significant change in elevation takes place at the waterfall. The base of the gut is composed of soil in the upper portion, changing slowly to bedrock through the middle portion, and finally to a concrete storm drain at the lower portion.

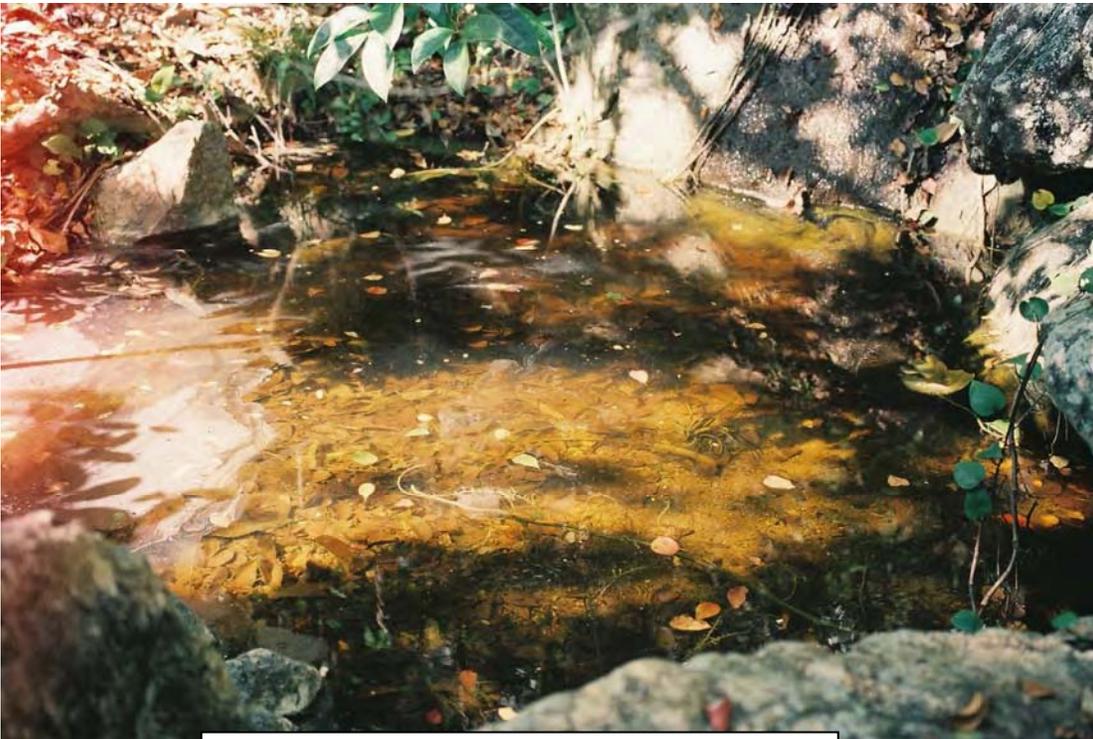
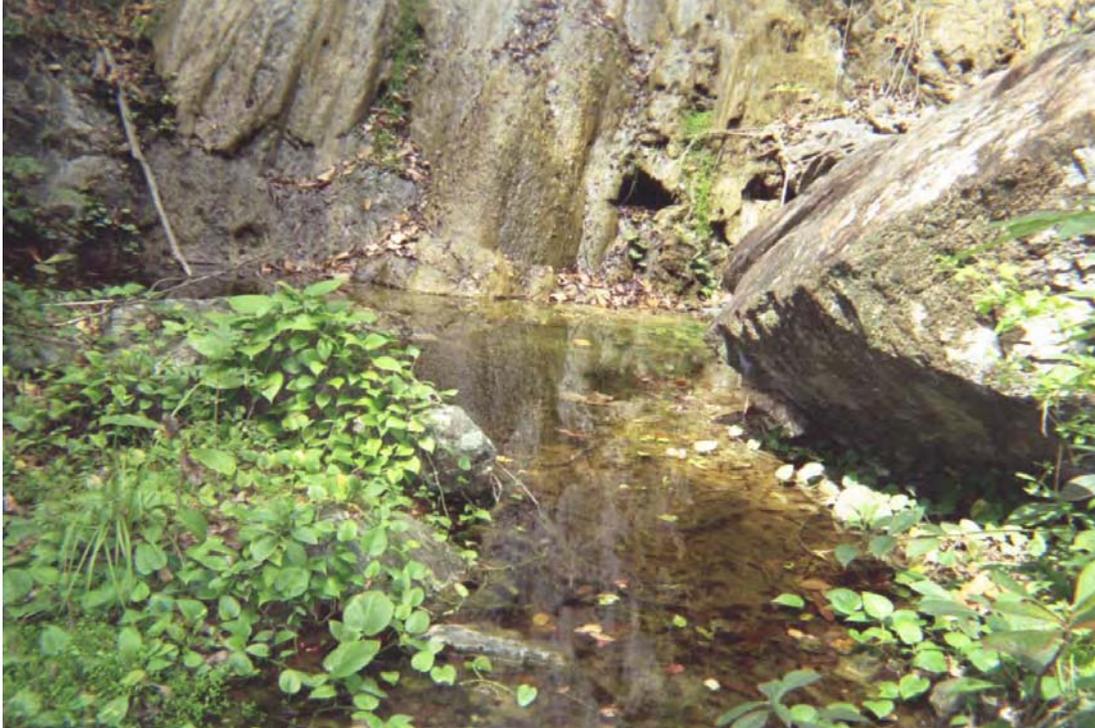
Pools of water of varying sizes (Photos 19 and 20) are found in the middle portion of the gut (immediately above and below the waterfall). There is a consistent, if very small, trickle of water over the falls that maintain the permanent pools below.

Photo 19: Pool above Waterfall - Contant Gut

Photo 20: Pool immediately below Waterfall - Contant Gut

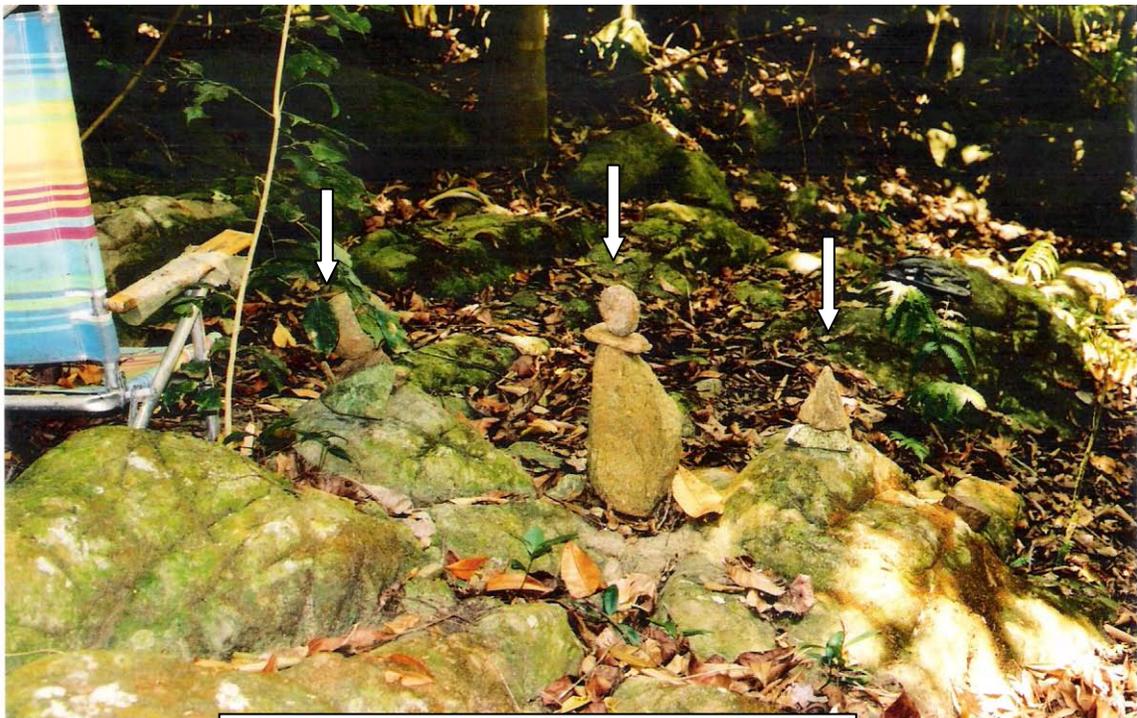
Photo 27: 'Rock Art' in Bonne Resolution Gut

- (i) Recreation – catching shrimp, hiking, and provision of access to the beach (latter activity observed at Smith Bay).
- (ii) Water Supply – for animals and crops.
- (iii) Waste Disposal – solid waste, effluent, and construction waste (such as the concrete mix deposited into the Frenchman's Bay Gut). The construction of a small wooden building in the gut in upper Contant (Photo 26) suggests that guts may be used for sewage disposal by residents in isolated cases. Additionally, a number of sewerages operated by the V.I. Waste Management Authority use guts as discharge points when a treatment facility has to be bypassed to facilitate emergency repairs to a line or pump station.
- (iv) Spiritual Renewal – This explanation was provided by a resident when questioned about the “rock art” observed in the Bonne Resolution Gut (Photo 27).

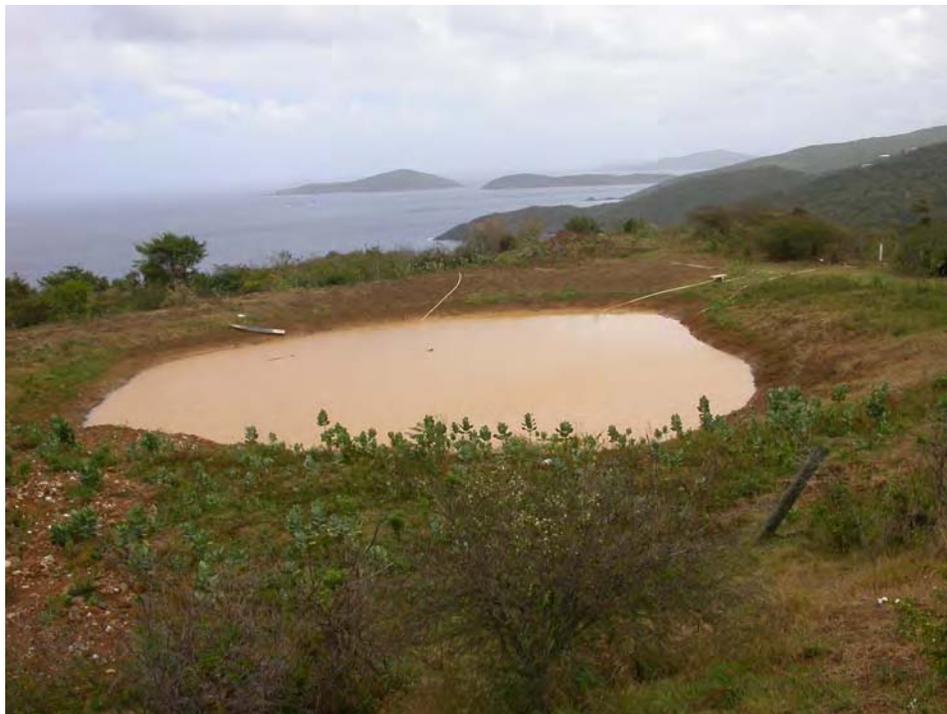
One use of watercourses that deserve special attention is the collection of water for agriculture. On St. Croix, this is usually done by construction of ponds by individual farms to collect surface runoff. In the Bordeaux area (western end) of St. Thomas, three ponds have been constructed at the bottom of three different watercourses to store surface runoff for watering crops (Photo 28). Given the mountainous terrain on St. Thomas, this method of storing freshwater for agriculture should be considered for wider use. A system of collection from different points in a watercourse could also be devised to augment the end-of-pipeline approach currently being used.

Photo 28: Water Storage Pond in Bordeaux

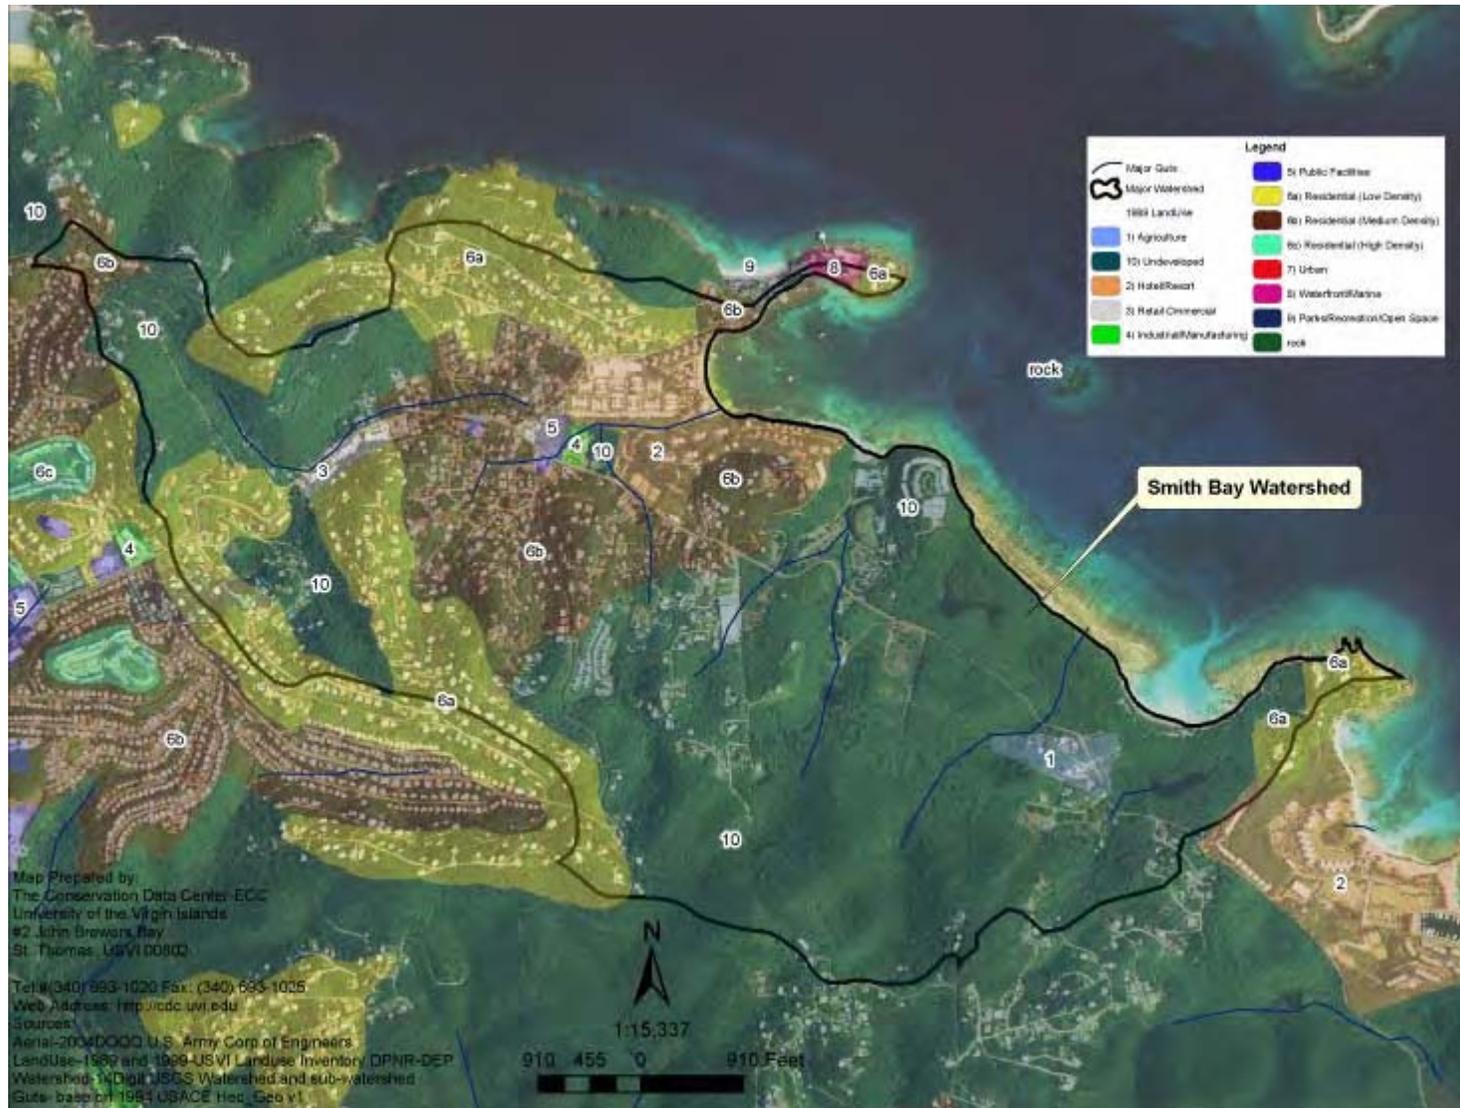
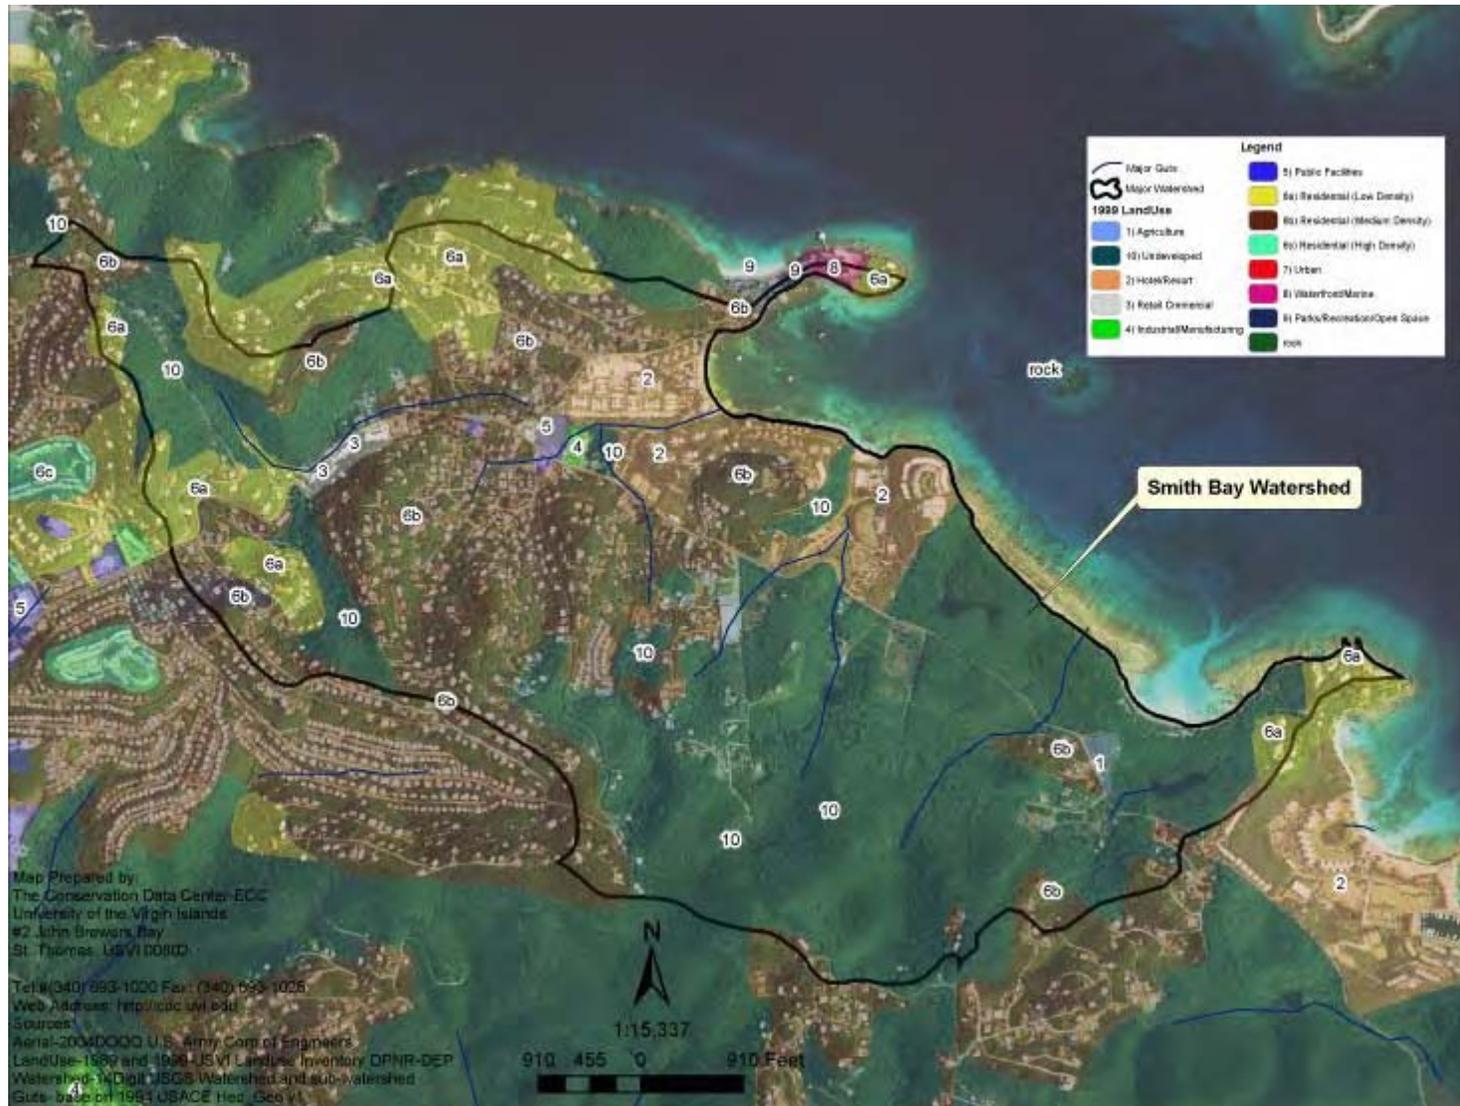
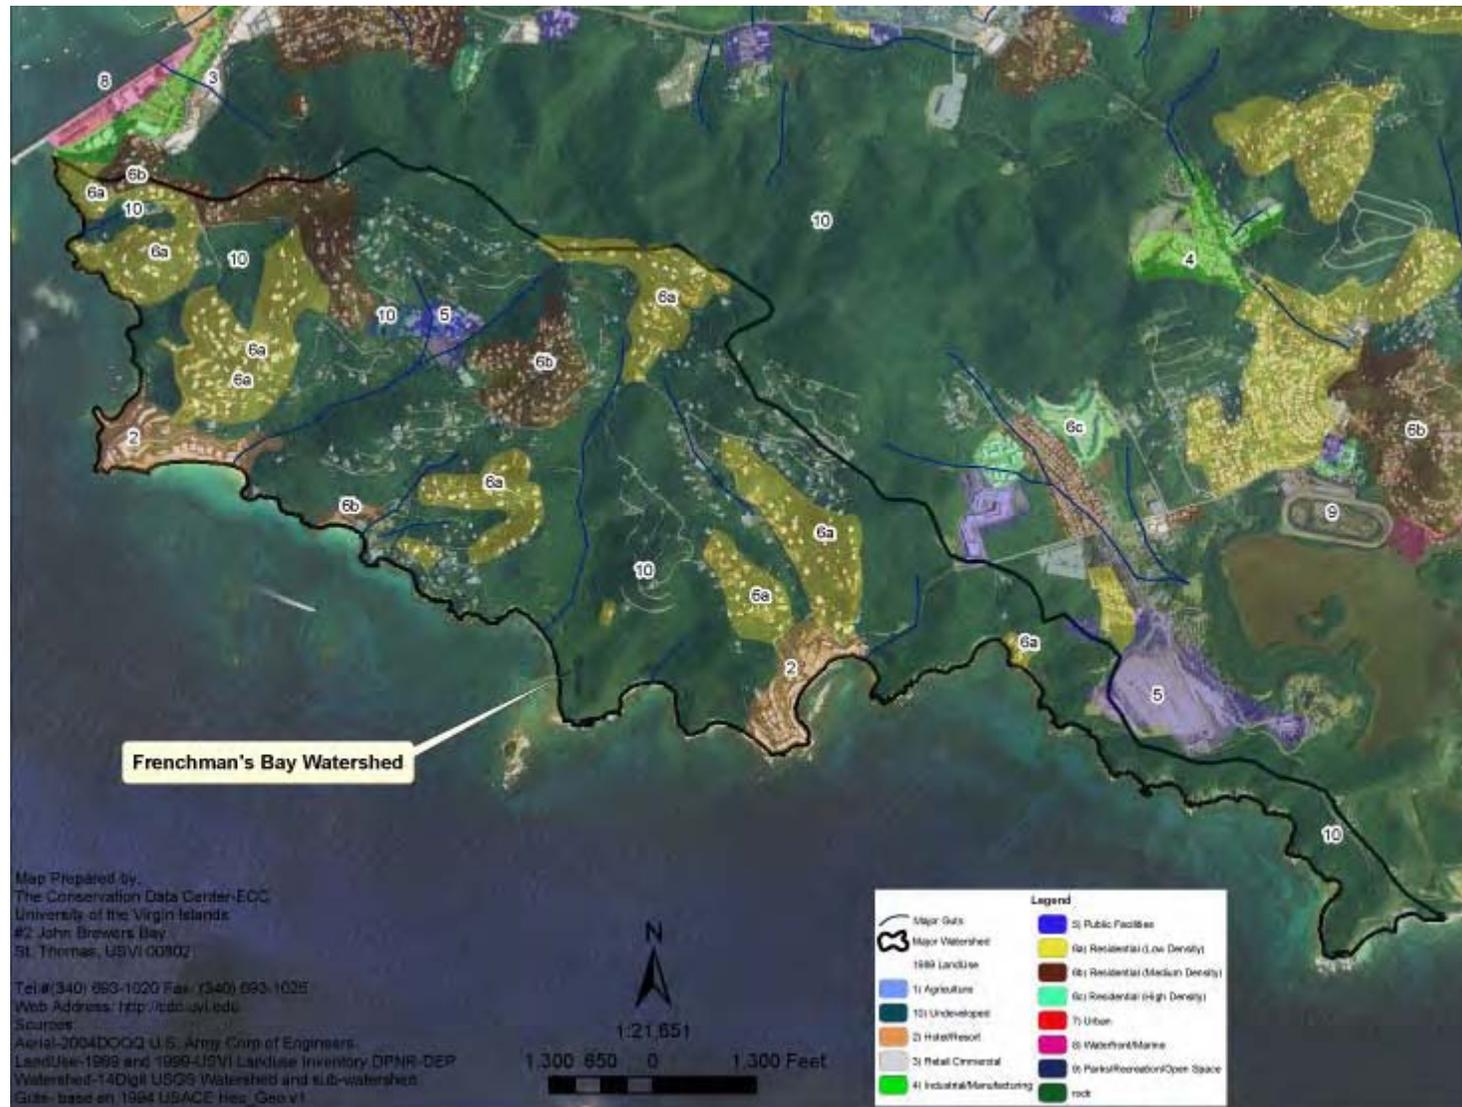
The land-use maps are projected on the 2004 aerial photograph. As such, interpretation of these maps should be based on the land-use categories, not on the physical features (such as buildings) seen on the photographs.
