Impervious Surface Analysis of Terrestrial Watersheds of the US Virgin Islands

November 2008

Water Resources Research Institute
University of the Virgin Islands
St. Thomas, USVI 00802

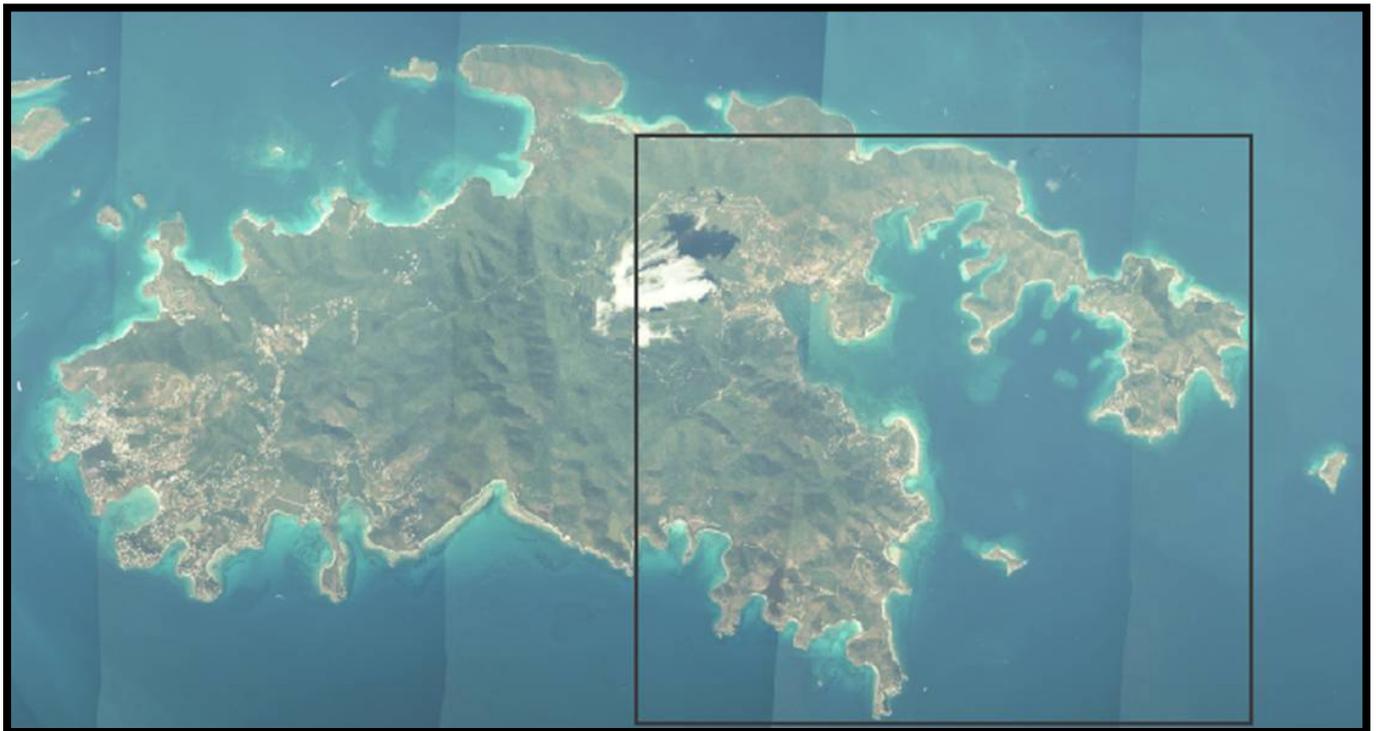
Figure 1. The study site of the Coral Bay watershed on St. John, USVI. (Image from NOAA/NOS, 2001)

Coral Bay is a large, picturesque bay on the eastern side of St. John, USVI (18.35°N, 64.71°W) (Figure 1). Its watershed encompasses an area of 18,851 ha and ranges in elevation from sea level to approximately 375 m. The Coral Bay watershed has one of the highest growth rates in the Virgin Islands, and, as a consequence, nonpoint source pollution and the pressure for new coastal development have been increasing.

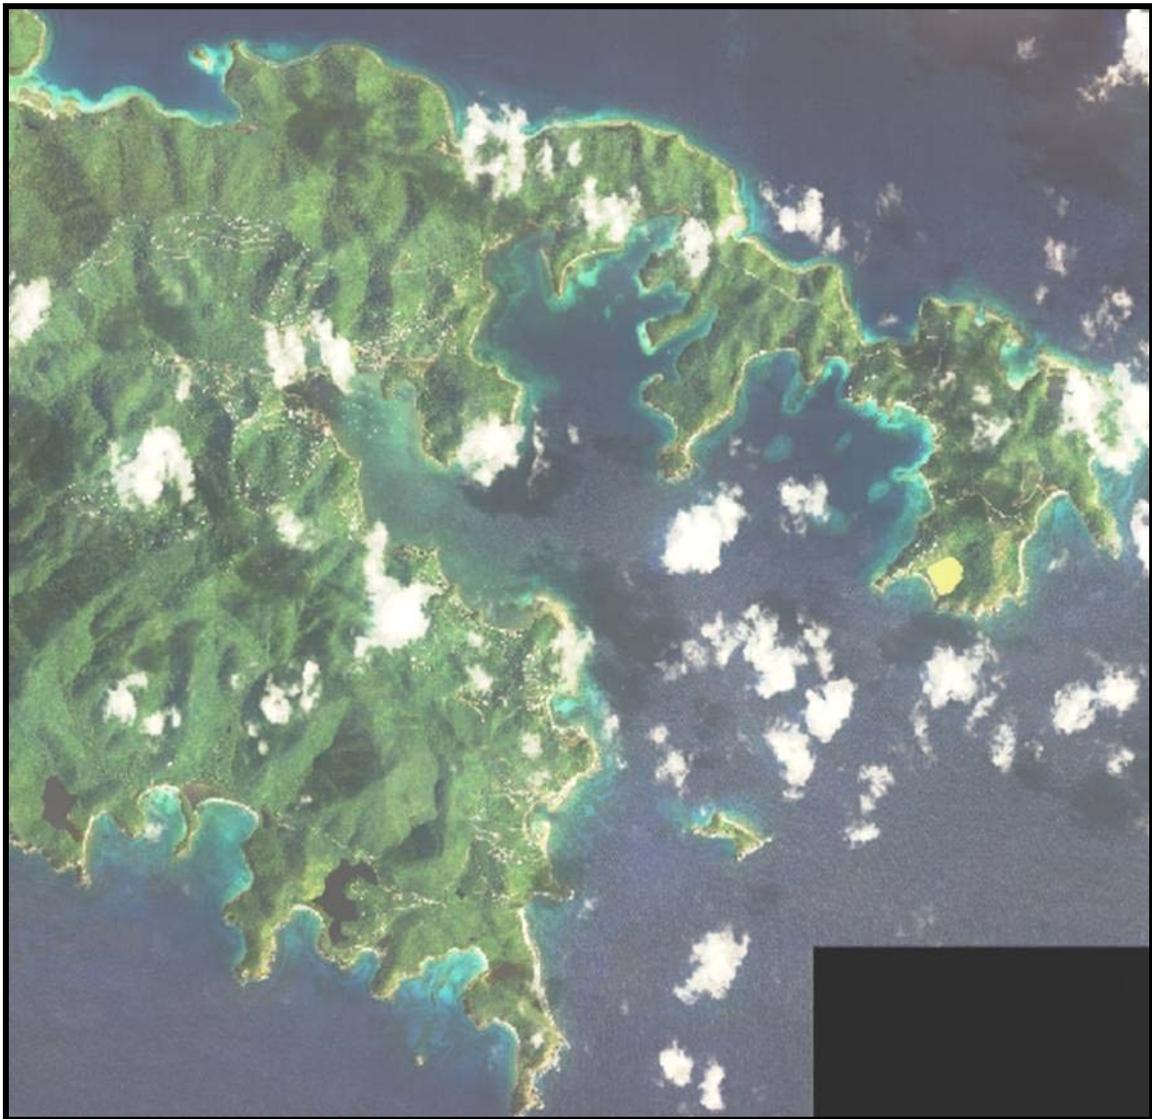
Figure 2. Aerial imagery of the Coral Bay watershed, September 2004 (NRCS/USACE, 2004).

The aerial photography imagery from September 2004 (Fig. 2) was our initial target imagery as it was both high quality and high resolution. In aerial photography the color is a film-recorded product as opposed to a radiometric measurement as in a satellite

multispectral scan. This can introduce errors into multispectral classification schemes because the color values are not radiometrically calibrated. Because it is generally limited to three color bands or may only have one band, i.e., panchromatic (black and white), aerial photography imagery is very restricted in the digital image processing that can be used. For instance, unless the color bands include a near IR band, the generation of standardized vegetation indices, such as discussed below, is not possible. The color bands available from the NRCS/USACE 2004 aerial photography were the traditional red, green, and blue bands.

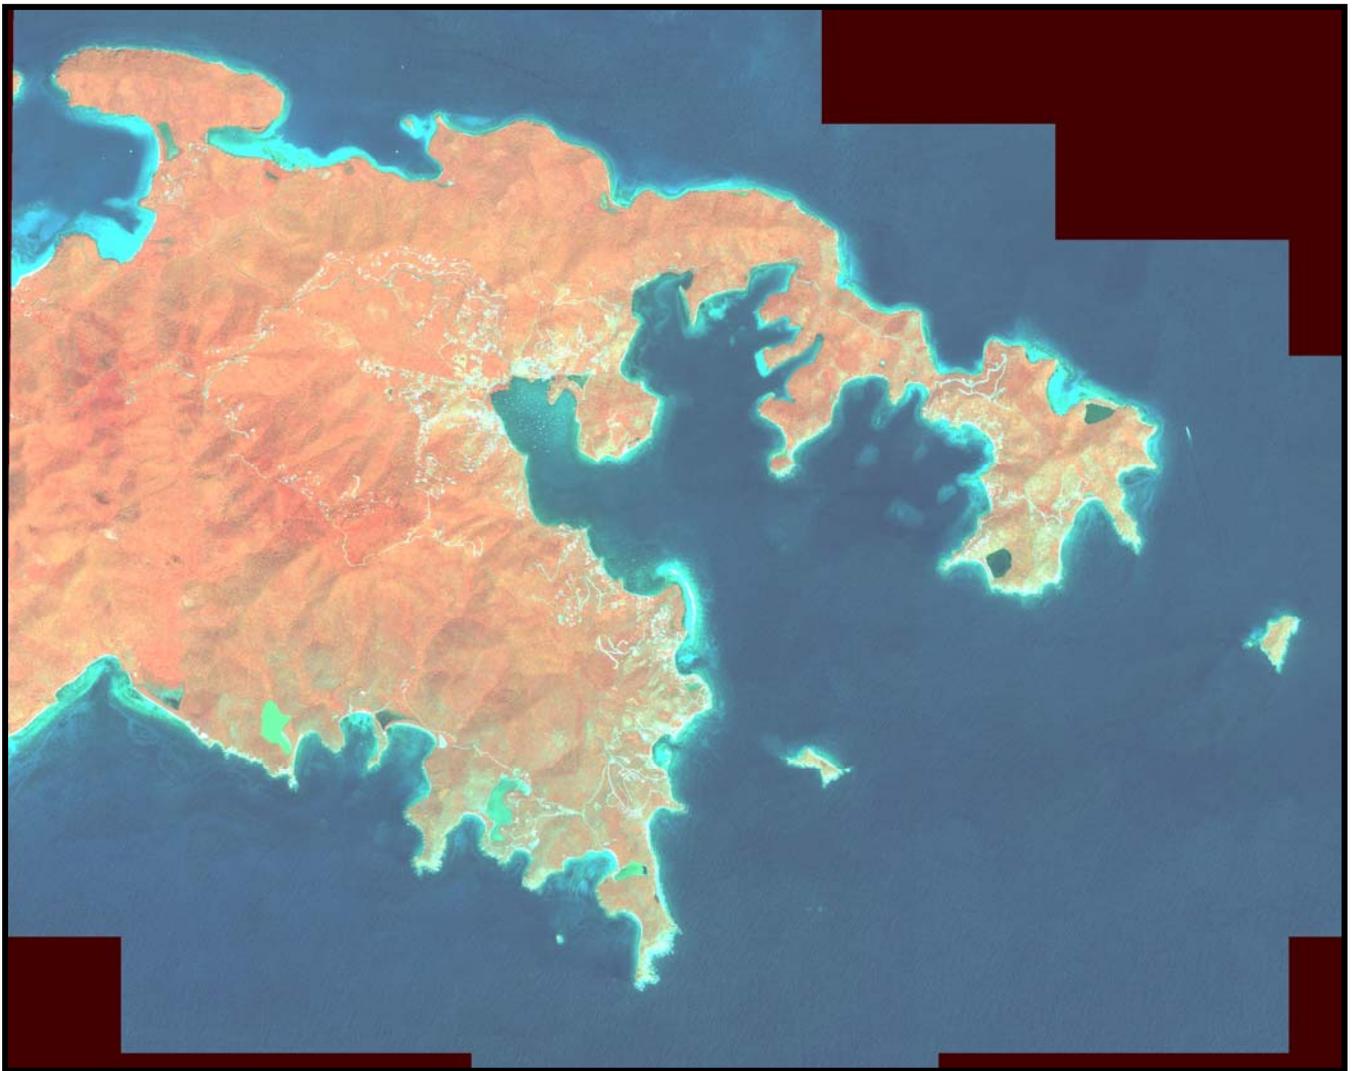
Figure 3. IKONOS imagery (September 2005) of eastern St. John, USVI. (Image © Space Imaging LLC, all rights reserved).

Both the 2004 aerial photographs and IKONOS imagery sets available for this study have significant amounts of cloud cover, a perennial problem in the tropics, obscuring areas of interest. Following an examination of the eight IKONOS sets, we chose the imagery of September 19, 2005 (PO-177850) for this project because it had much less cloud cover over the Coral Bay watershed. After digital image processing, a mosaic of the IKONOS imagery was made to produce a single image of St. John (Fig. 3; for metadata, see Appendix I).

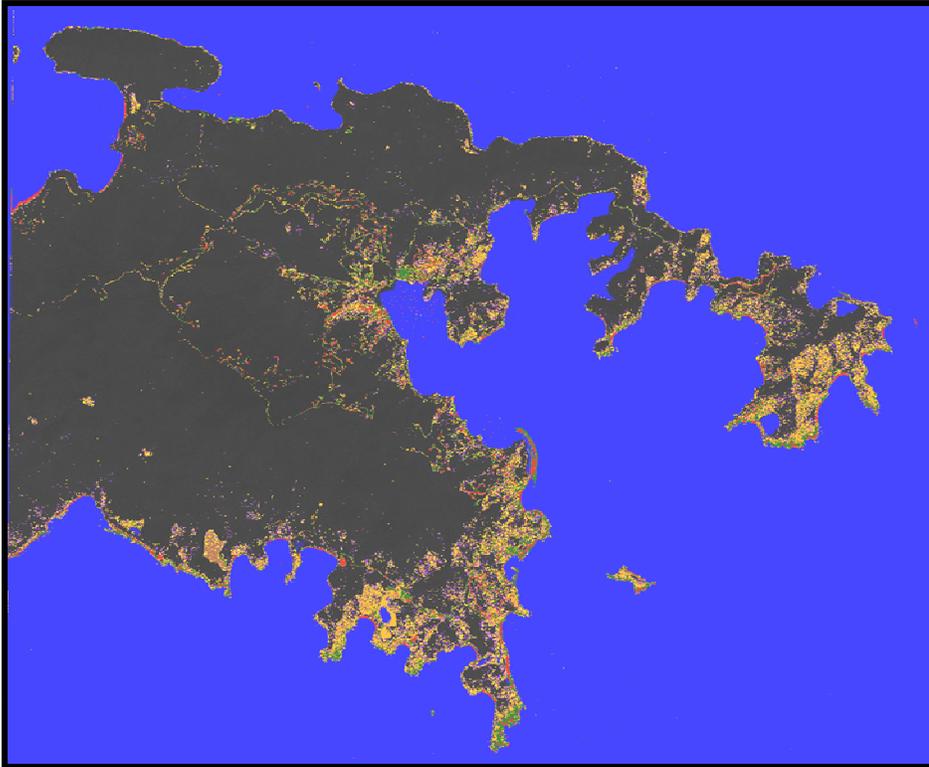
Figure 5. IKONOS image with water masked using the near IR band (includes material © Space Imaging LLC, all rights reserved).

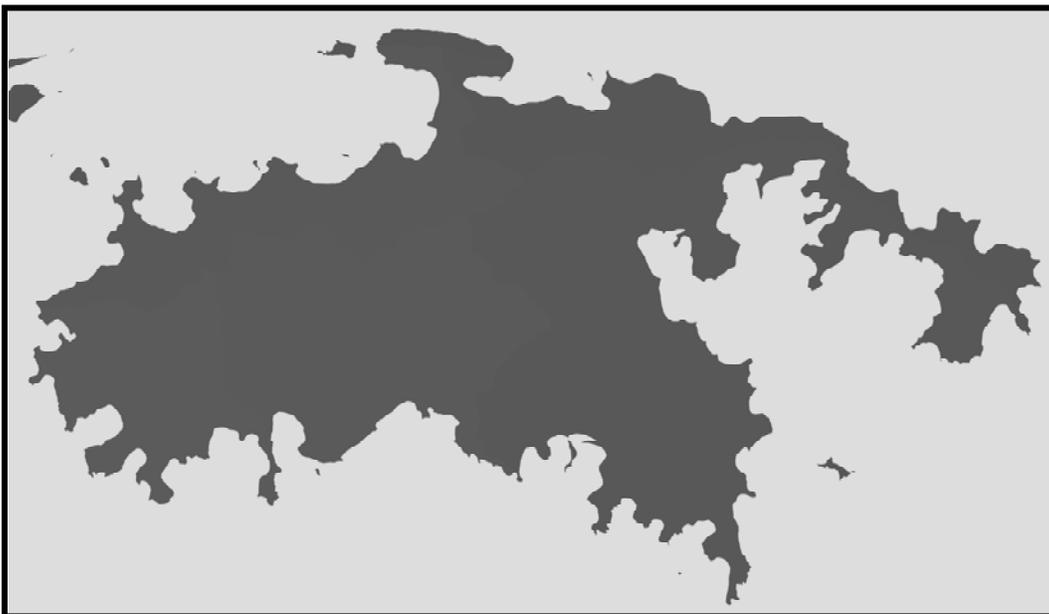
Figure 6. St. John shoreline using a 10-pixel wide boundary overlaying the IKONOS image (includes material © Space Imaging LLC, all rights reserved).

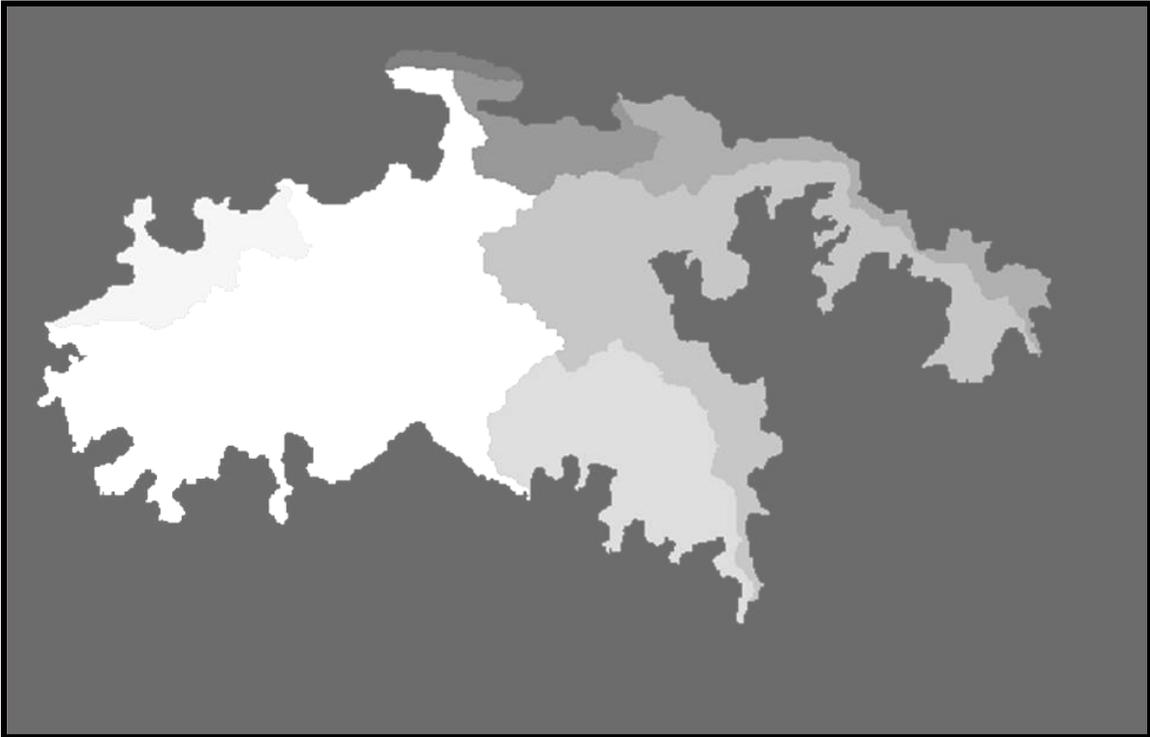
Figure 8. Watershed boundaries of St. John overlaying the IKONOS image (includes material © Space Imaging LLC, all rights reserved).

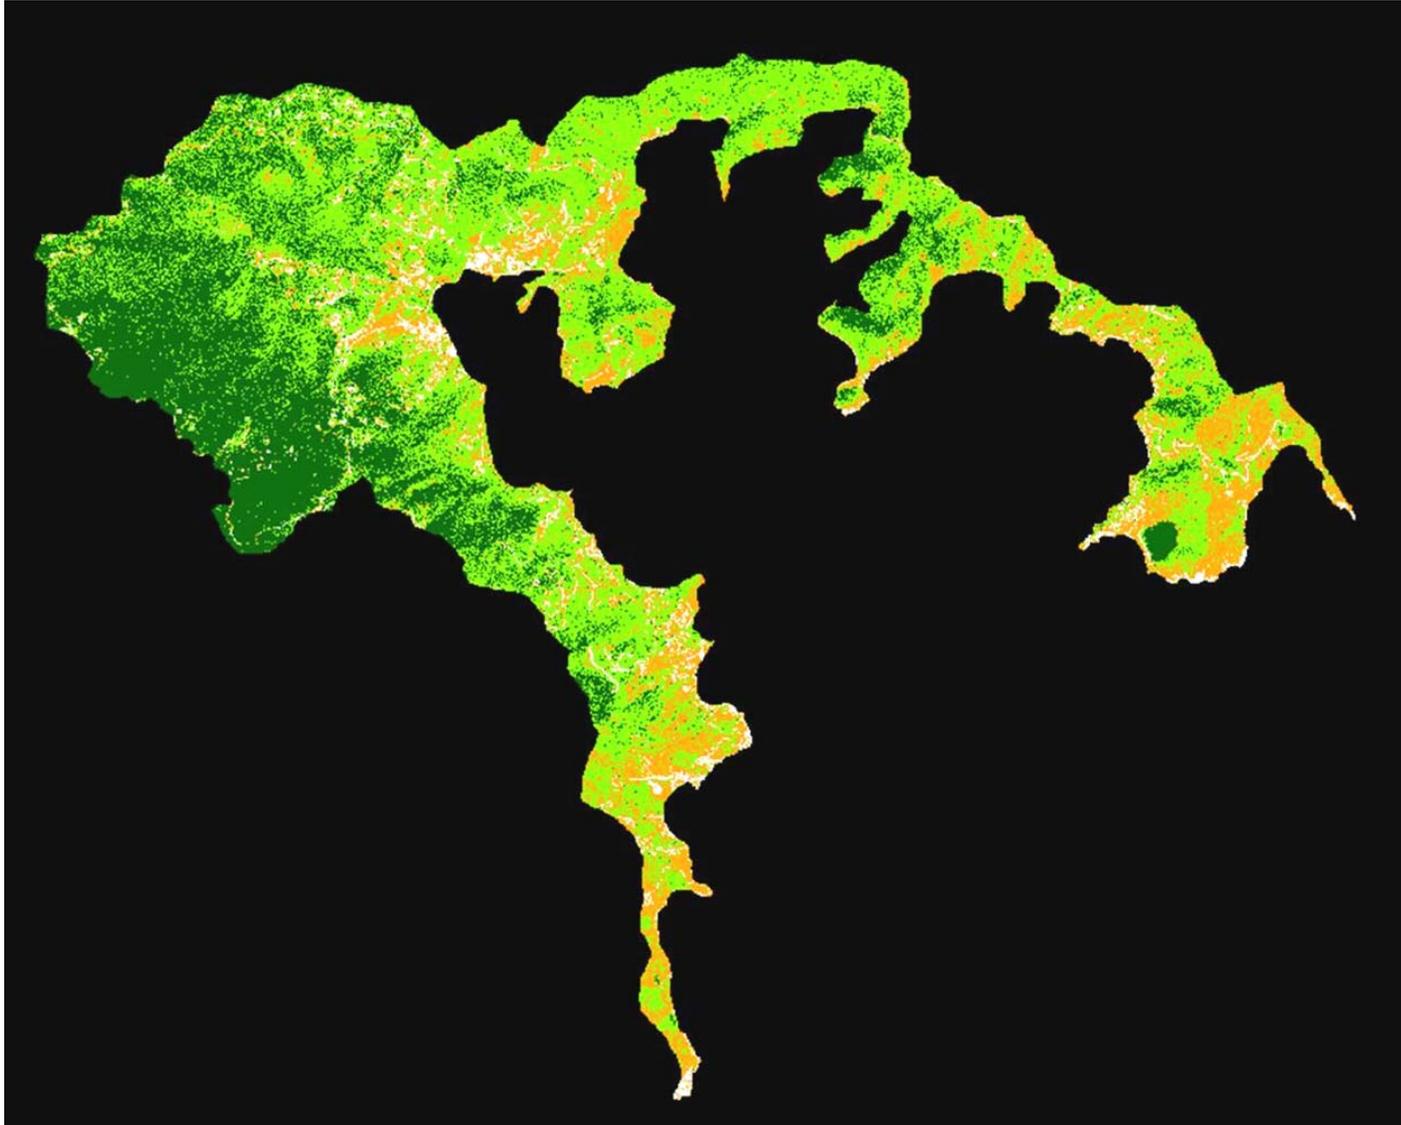
Figure 13. Classification of the Coral Bay watershed with five clusters (includes material © Space Imaging LLC, all rights reserved).

We performed unsupervised classification of the multispectral image data, using the iterative self-organizing data analysis technique (ISODATA) (Tou and Gonzalez, 1977 in Jensen, 1996), which groups pixels into spectral clusters. We experimented with cluster number for discriminating the spectral values of impervious surfaces and specified criteria for the algorithm that generated 5, 10, and 20 clusters. We compared these cluster combinations and found that extraneous speckling was greatest and resolution of different types of impervious surfaces was least when clusters were limited to five (Fig. 13) and speckling was least and impervious surface resolution greatest at 20 (Fig. 14).

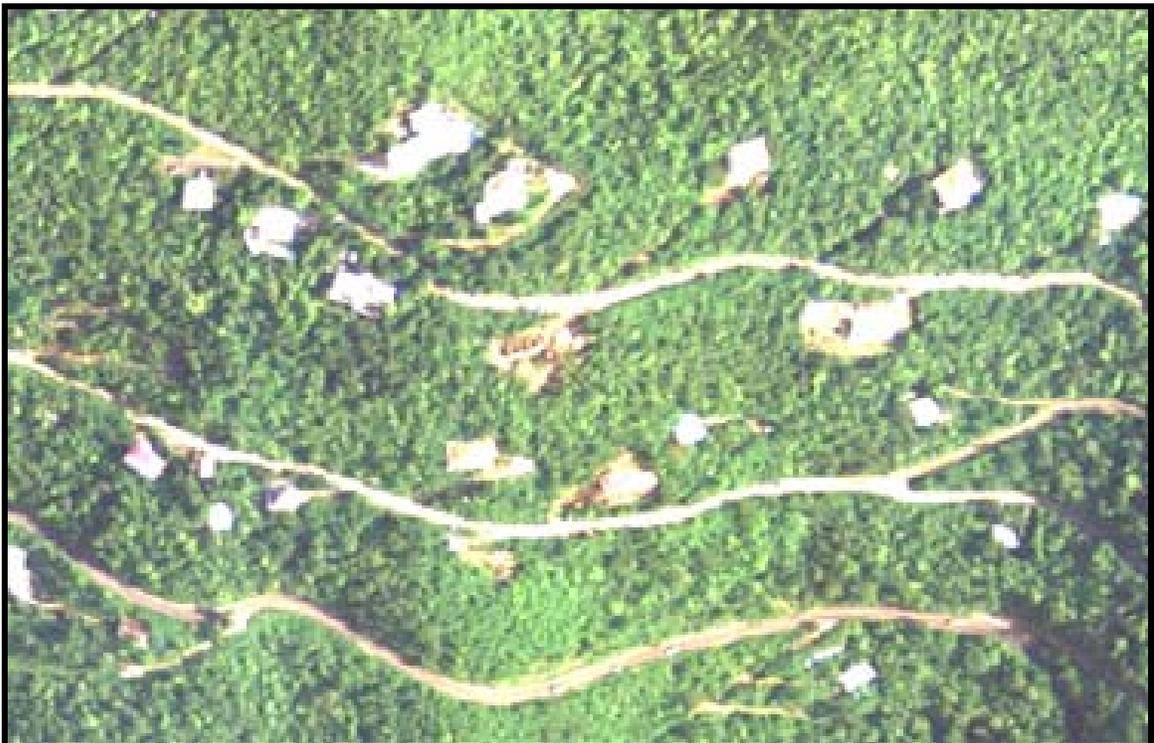
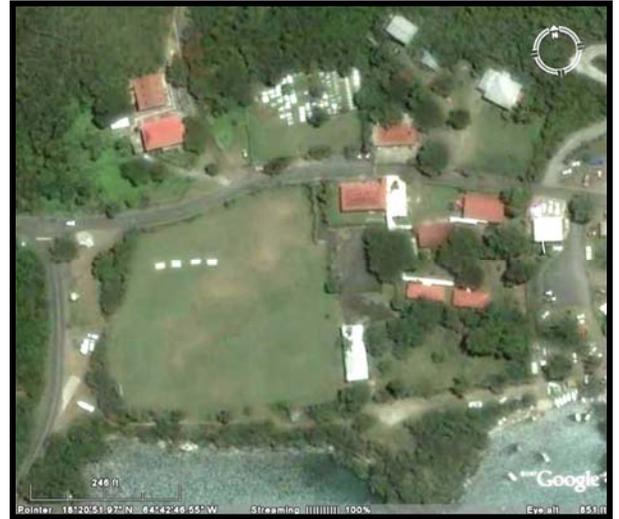
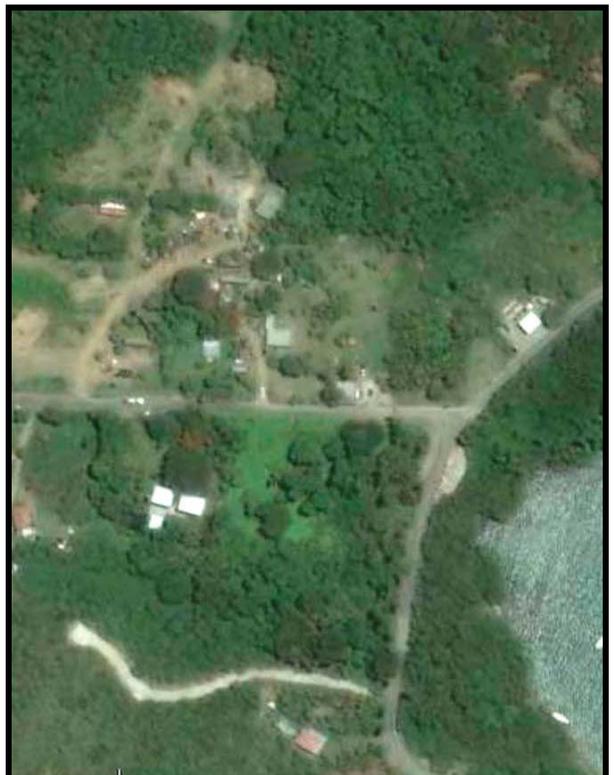
Figure 17. Details of the five selected IKONOS subsets (left) with approximate corresponding ground view (right): A) coast east, ground view from NRCS/USACE, 2004; B) coast south, ground view from Google Earth, 2008 (no 2004 cloud-free image available); C) upland north, ground view from NRCS/USACE, 2004; D) town, ground view from Google Earth, 2008 (no 2004 cloud-free image available); and E) town south, ground view from Google Earth, 2008 (no 2004 cloud-free image available) (includes material © Space Imaging LLC, all rights reserved).

Five subsets of the watershed were selected based on location and spectral analysis for validation (ground-truthing) of the features captured in the false-color clusters and for detailed impervious surface calculations. The five locations were from: the coast at the eastern end of the watershed, the coast in the southern part of the watershed, the upland area in the northern part of the watershed, the main part of the town of Coral Bay, and an area to the south of the town (Figs. 16, 17).

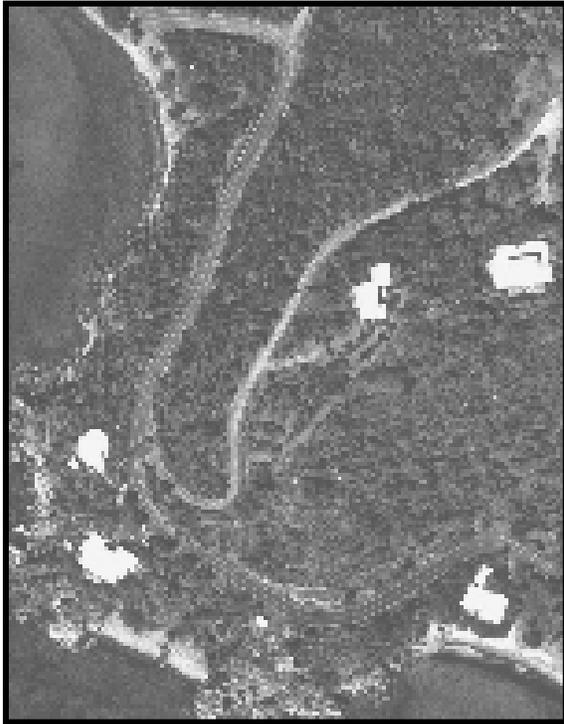
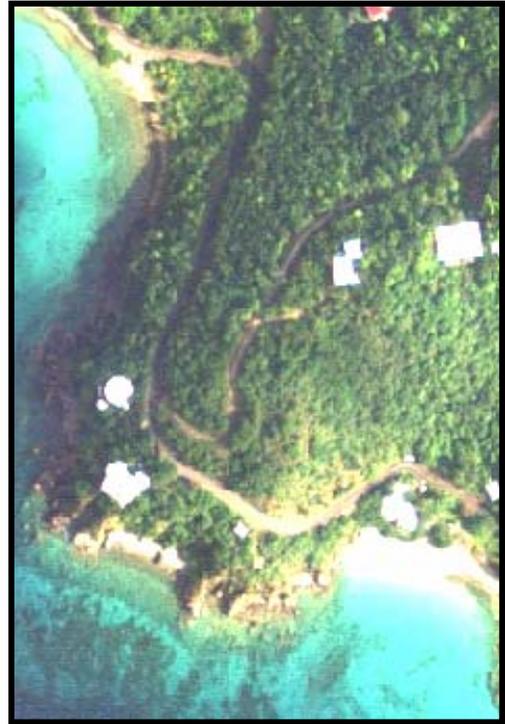
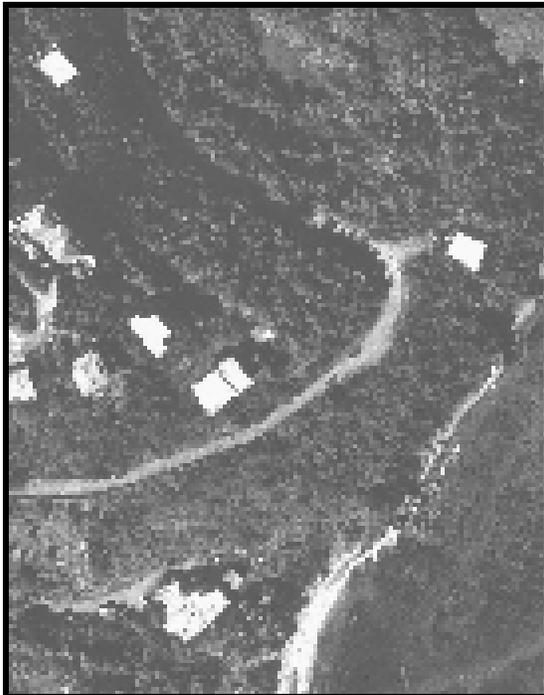
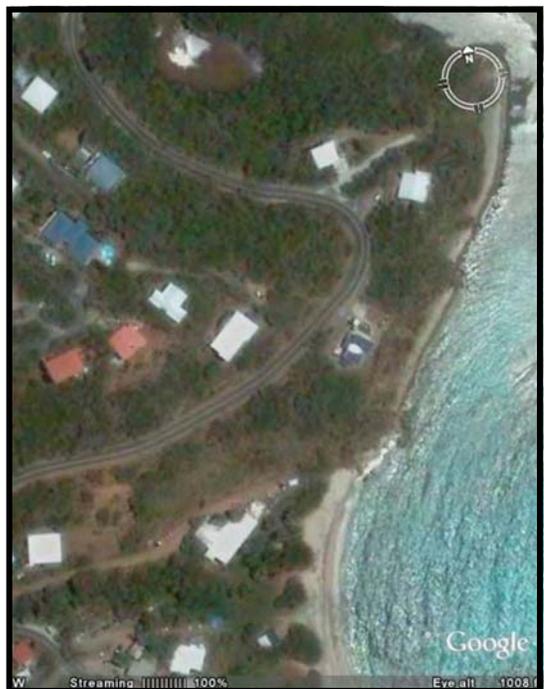
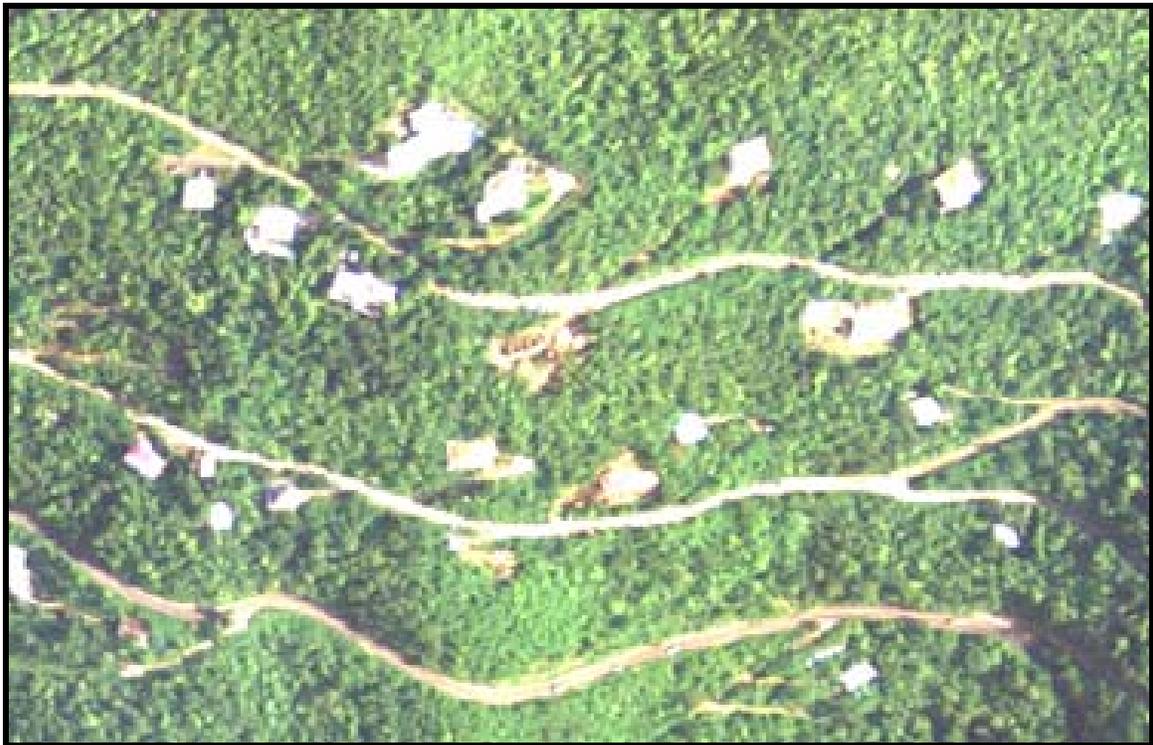
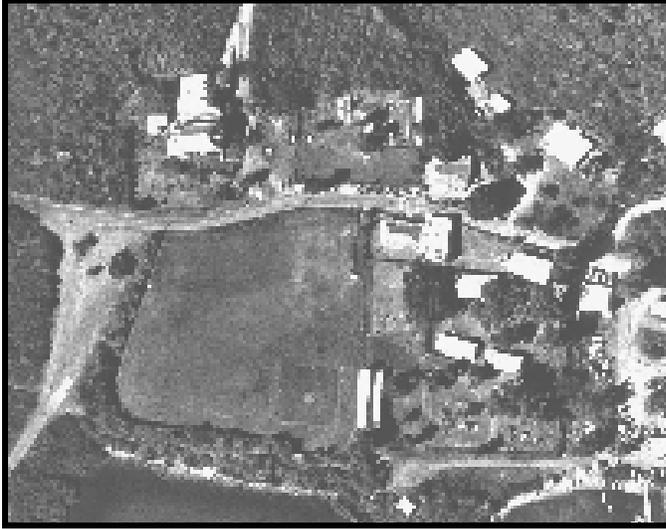
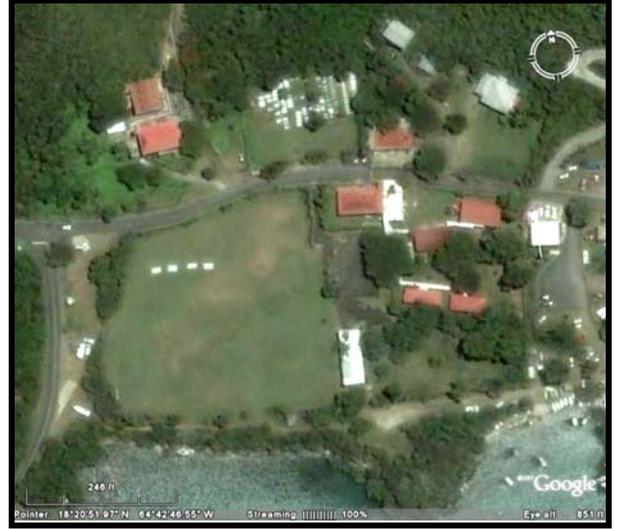
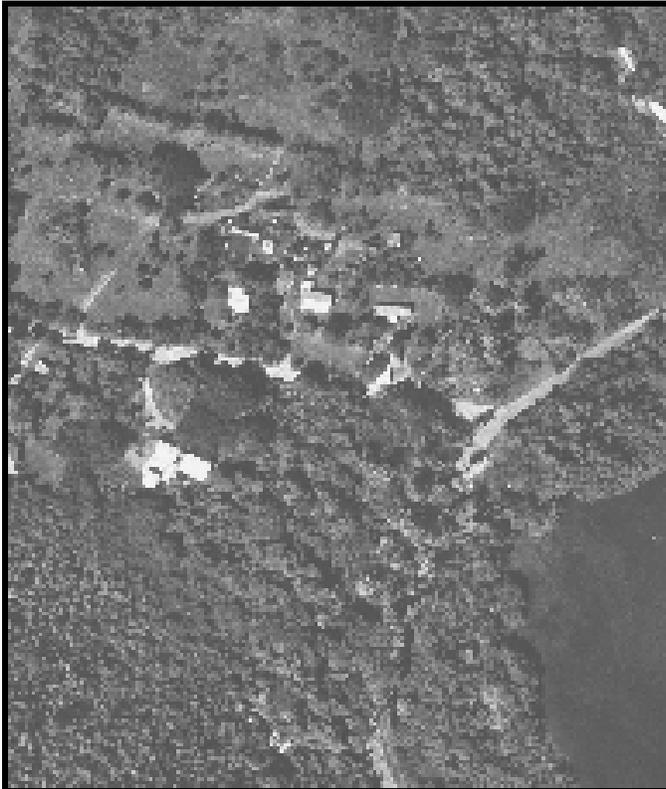
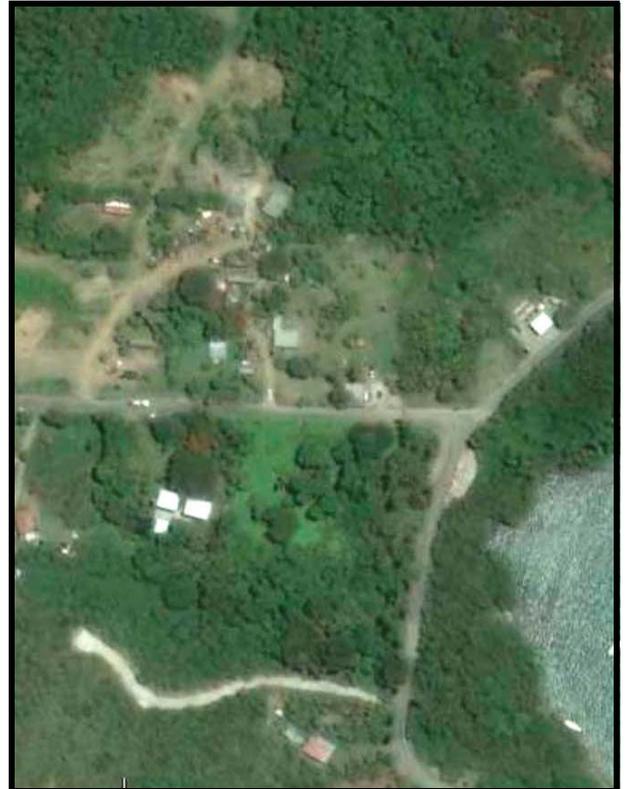
Figure 18. A comparison of the five selected subsets between 1994 (left) and 2004 or 2008 (right) (aerial photography from USACE, 1994; more recent images as in Fig. 17): A) coast east, B) coast south, C) upland north, D) town, and E) town south (includes material © Space Imaging LLC, all rights reserved)

For determining the change in impervious surface cover since 1994, black and white aerial photographs (USACE, 1994) were geolinked (see Methodology) to the five selected subsets of the IKONOS image. From the 1994 aerial photographs, impervious surfaces were visually identified as consisting of four types: houses, primary roads, secondary roads and driveways, and indeterminate disturbance (assigned as urban/residential compacted ground). Infiltration coefficients from the literature that best corresponded to these surface types were 5%, 100%, 90% (we assumed that most secondary roads and driveways in 1994 were unpaved), and 20%, respectively. Primary and secondary roads and driveways comprised most of the impervious surface cover, although there was also a large area of disturbed ground in the town (Table 9).

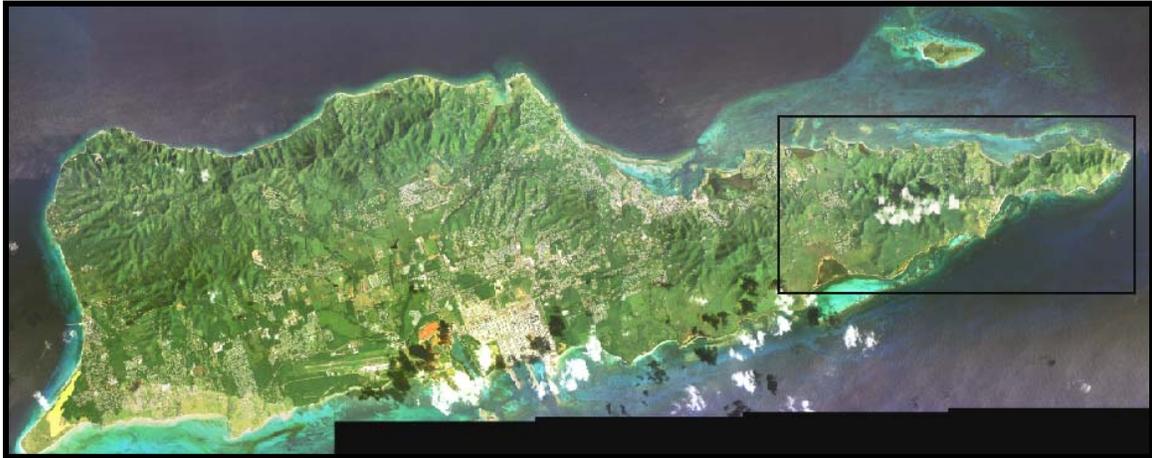
Figure 19. The watershed of the St. Croix East End Marine Park on St. Croix.
(from NRCS/USACE, 2004)

The marine park encompasses 155 square kilometers of territorial waters and has a shoreline of approximately 28 kilometers (17 miles) (Fig. 19). This extends around the entire east end of the island from the western border of Chenay Bay on the north shore east to Point Udall and then west to the western border of Great Pond Bay on the south shore. The land bordering the park is entirely within the First Tier of the coastal zone, and any development activity requires the approval of the Virgin Islands Coastal Zone Commission. Often the impacts of coastal development, and particularly the cumulative impacts, are not adequately addressed during project formulation or during the permitting process. Having current information on impervious surface cover in the coastal zone would aid coastal zone regulators in making decisions prior to granting permissions for development activity.

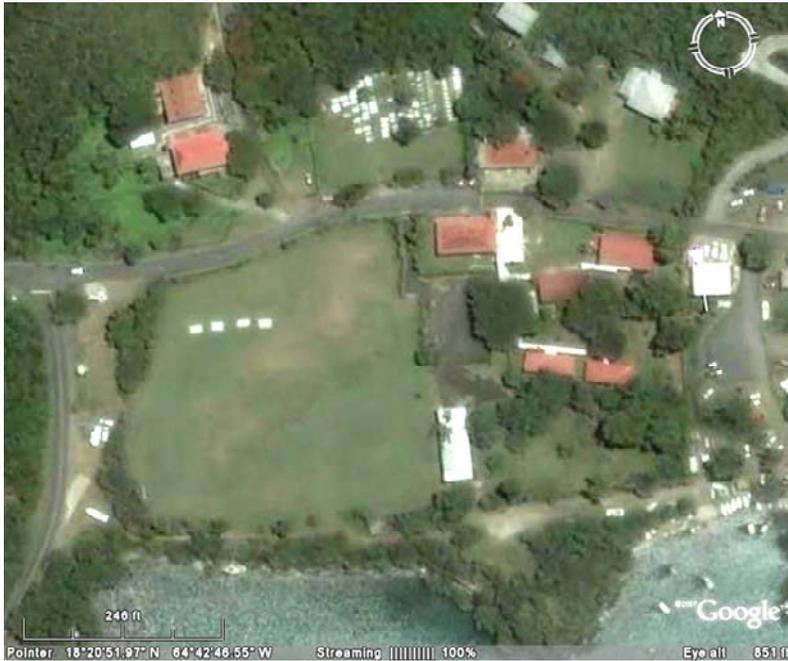
Roads and houses are common impervious surfaces that prevent rainfall from filtering through the ground to remove pollutants, such as soil runoff, fertilizers, and pesticides. Instead, these pollutants end up in coastal waters where they damage coral reefs and seagrass beds. This photograph from Google Earth (2008) shows the town of Coral Bay, St. John.
